Corrective Action Report

NDIC Site 1358-9
Dunn County, North Dakota

February 8, 2017

Terracon Project No. M1167113

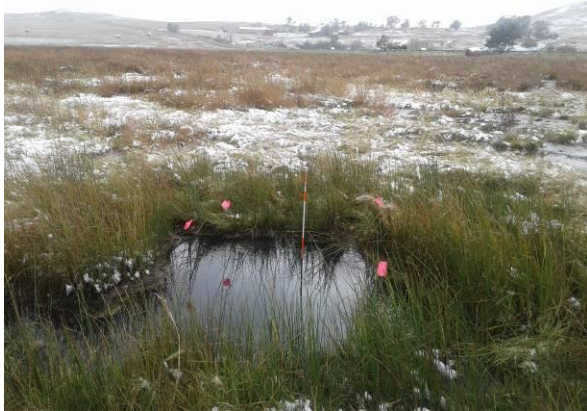
Photo #1 View of borehole 1358-9 (1).

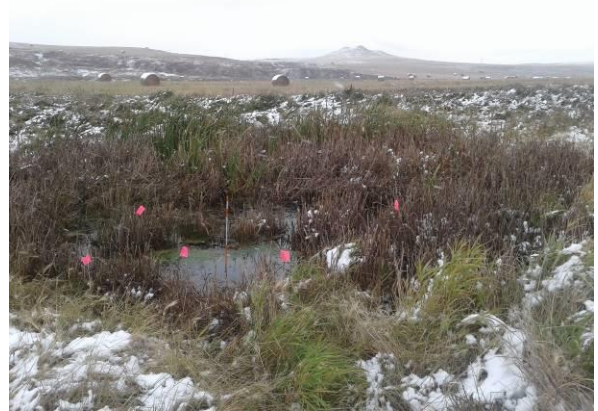
Photo #2 View of borehole 1358-9 (2).

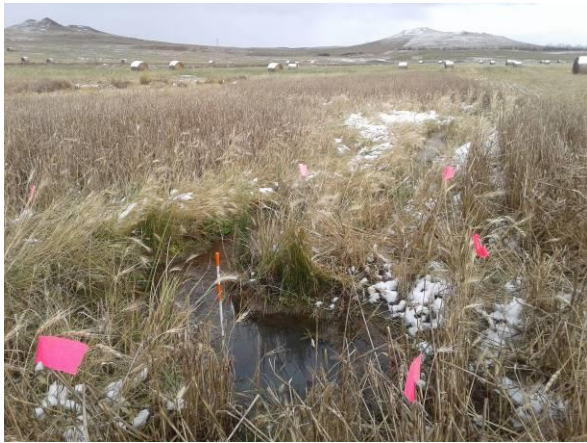
Photo #3 View of borehole 1358-9 (3).

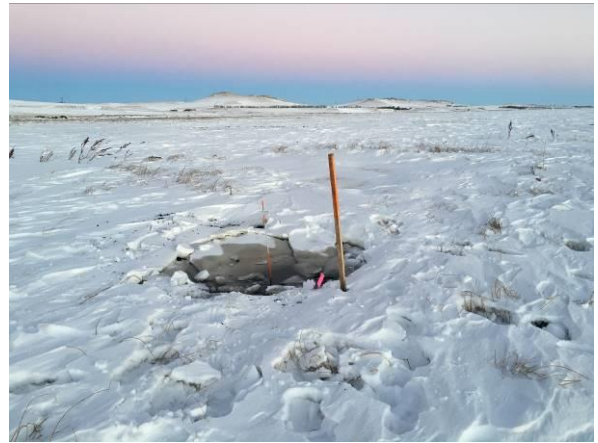
Photo #4 View of borehole 1358-9 (1).

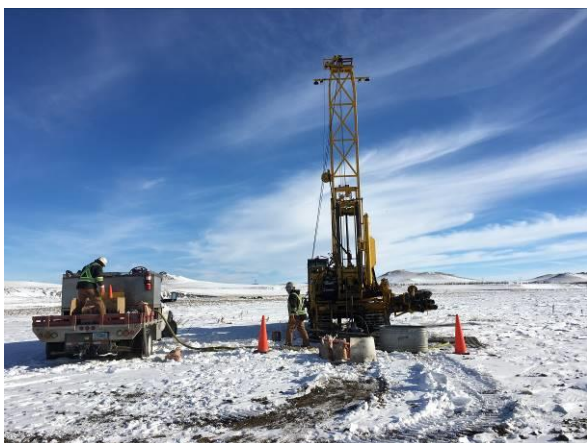
Photo #5 View east at the preparation of sealing borehole 1358-9 (1).

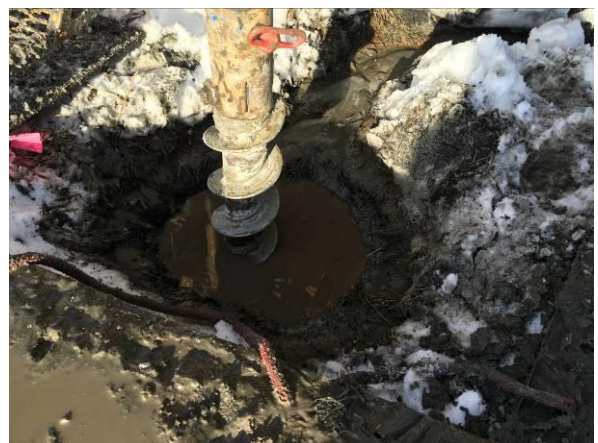
Photo #6 View at borehole 1358-9 (1) – groundwater stopped flowing at approximately 45 feet bgs.

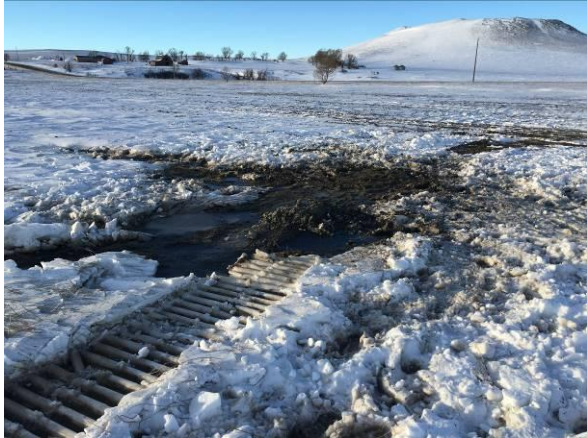
Photo #7 Sealing completion at borehole 1358-9 (1).

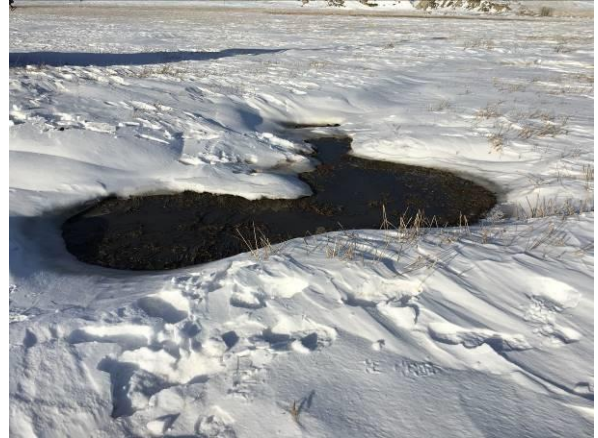
Photo #8 View of borehole 1358-9 (3).

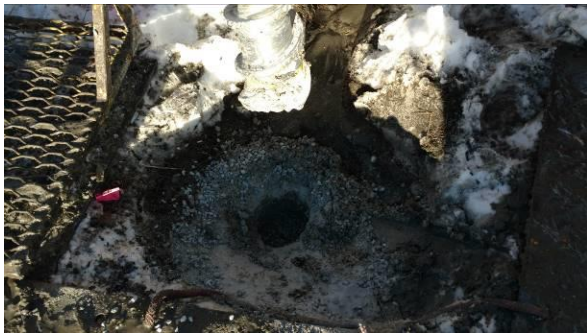
Photo #9 Sealing completion at borehole 1358-9 (3).

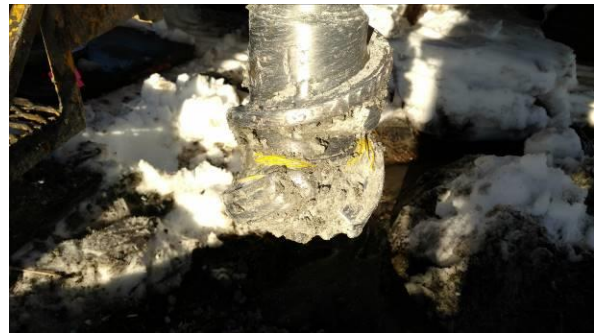
Photo #10 View of wiring wrapped around the auger from borehole 1358-9 (3).

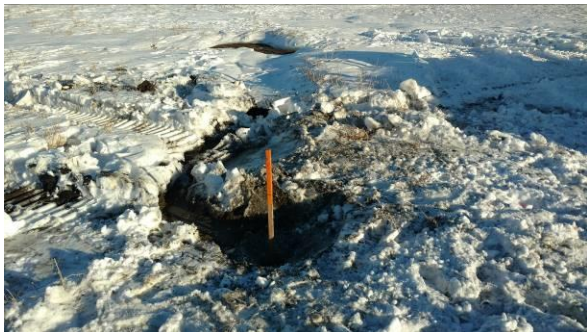
Photo #11 View of borehole 1358-9 (2).

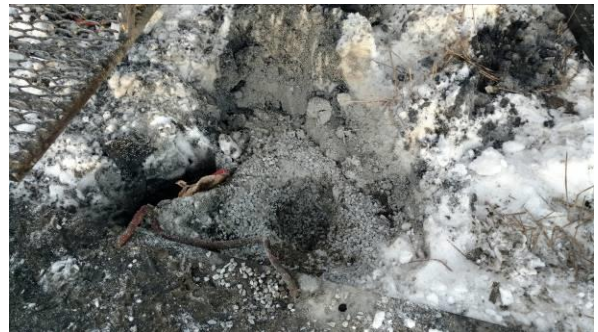
Photo #12 Sealing completion of borehole 1358-9 (2).

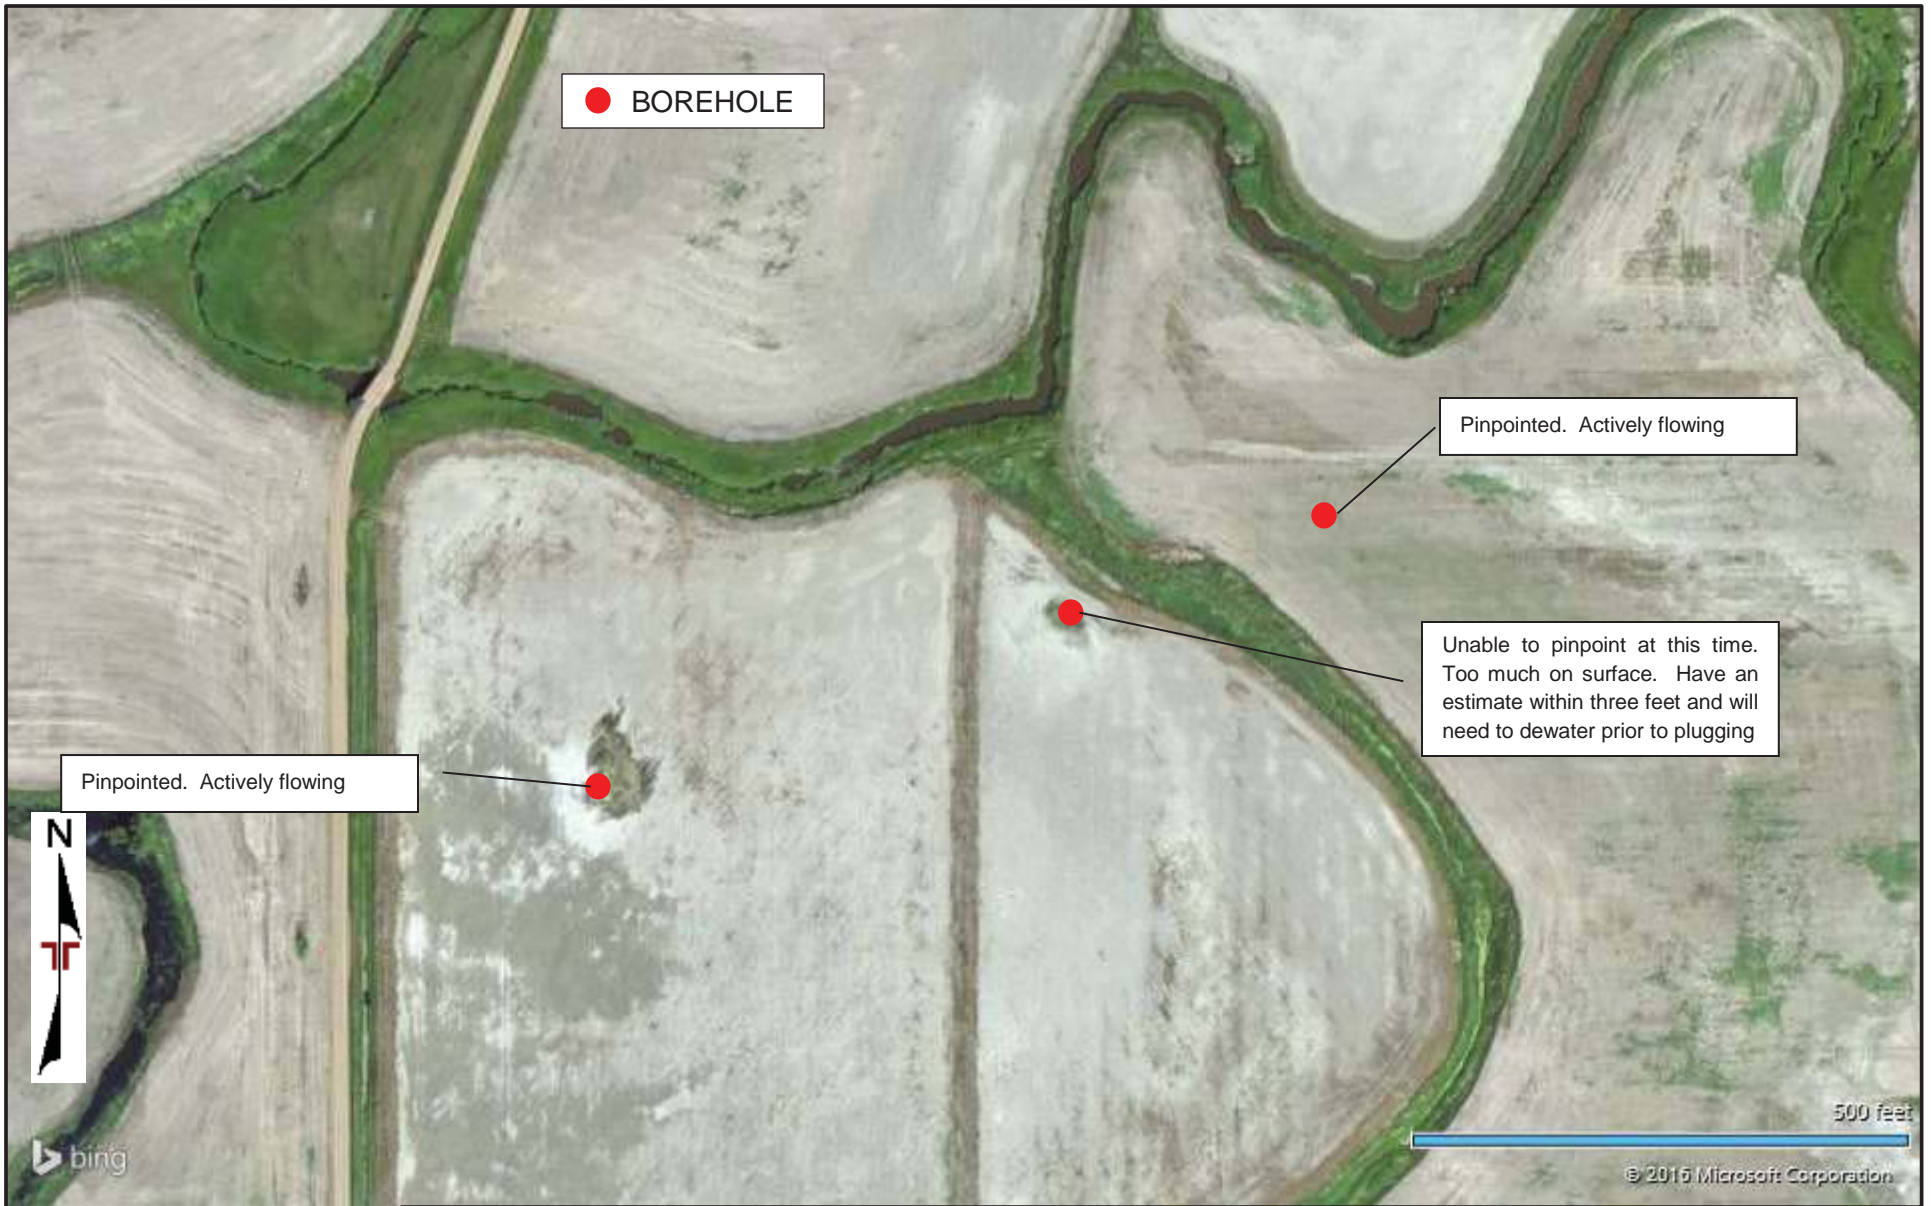
SITE DIAGRAM

Pinpointed. Actively flowing

Unable to pinpoint at this time.
Too much on surface. Have an estimate within three feet and will need to dewater prior to plugging
