# Corrective Action Report

NDIC Site 1358-14  
NW<sup>1</sup>/<sub>4</sub> of S8, NW<sup>1</sup>/<sub>4</sub> of S17, & E<sup>1</sup>/<sub>2</sub> of S6-T157N-R101W  
Williams County, North Dakota

March 12, 2020

Terracon Project No. M1187016

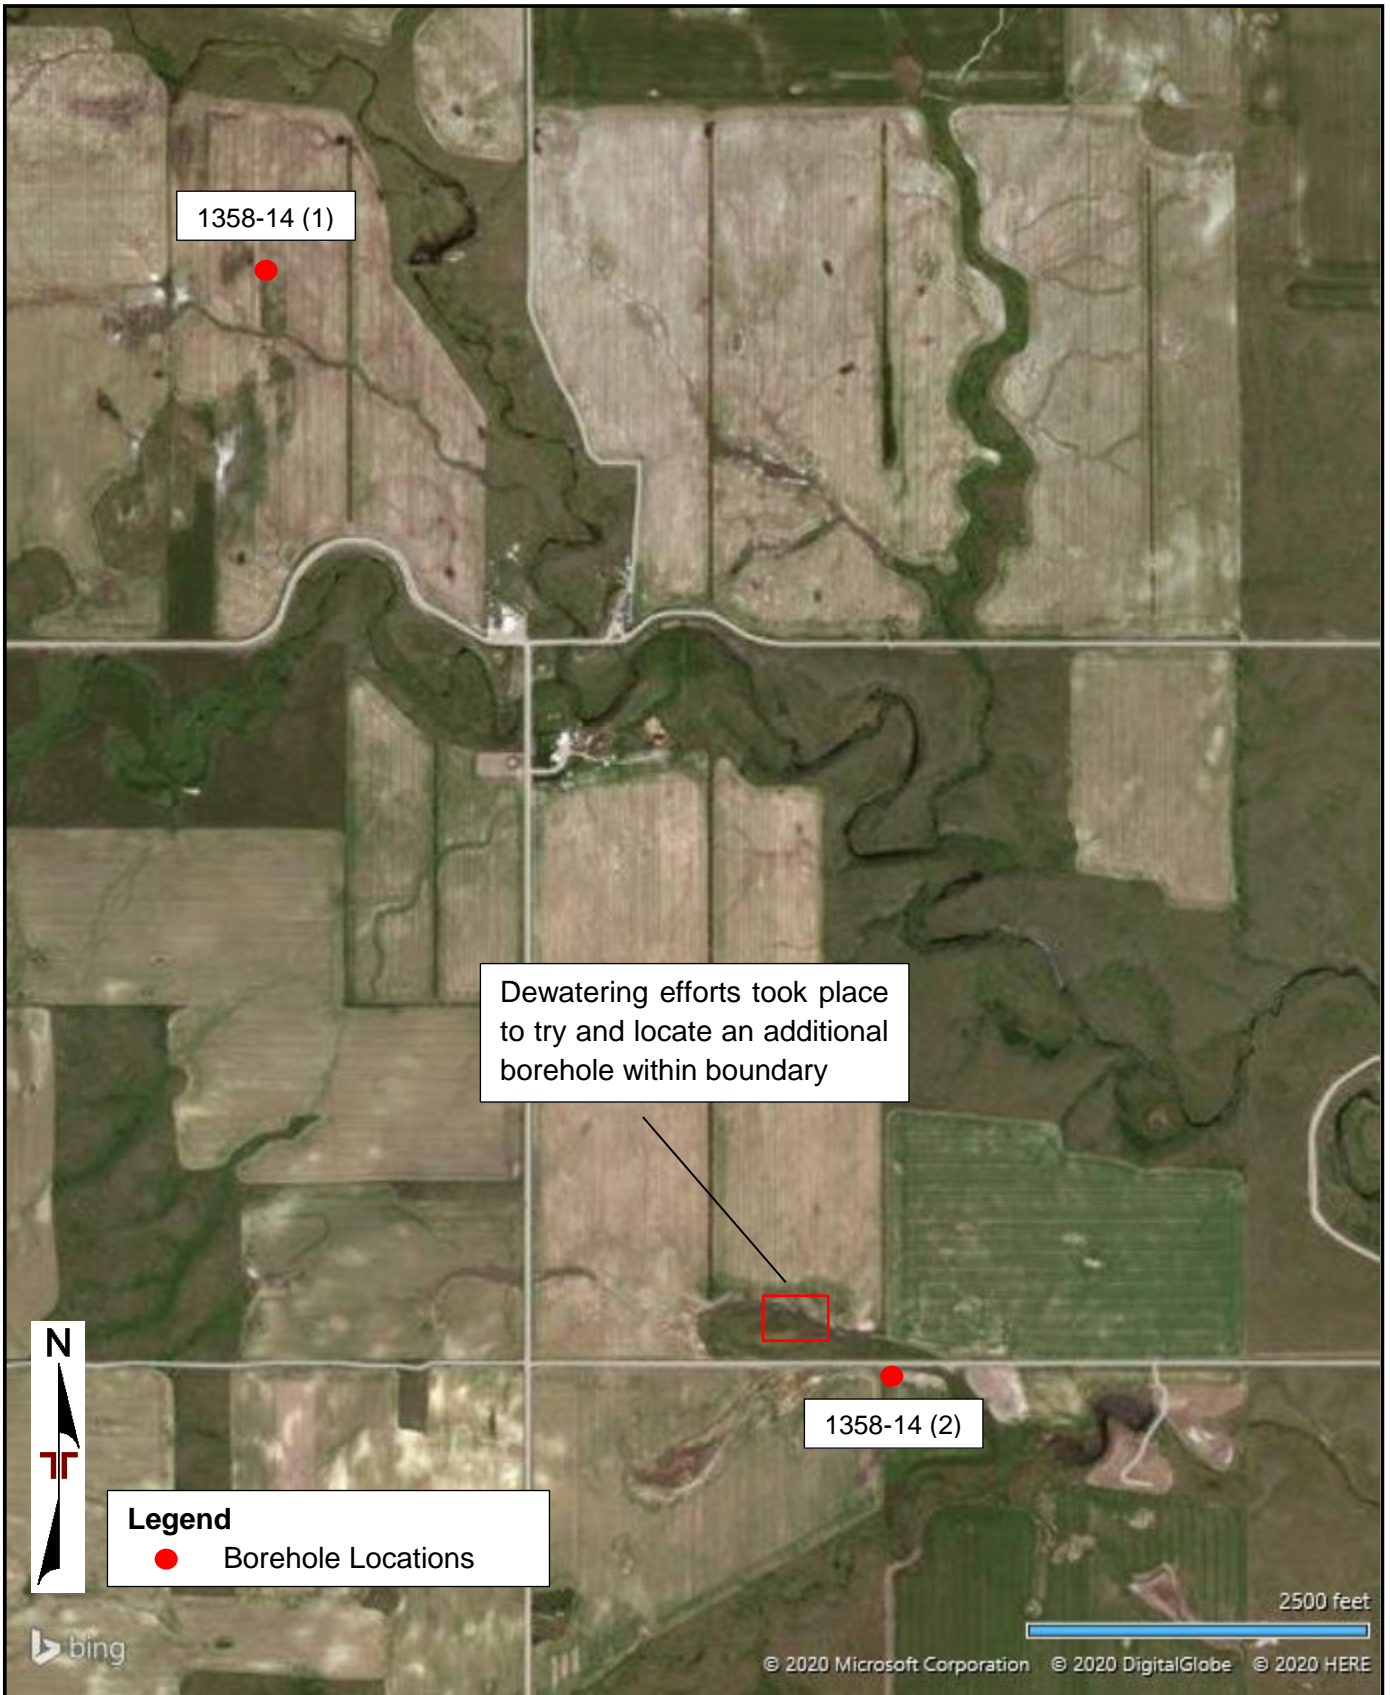
Exhibit
<b>2</b>

Dewatering efforts took place to try and locate an additional borehole within boundary

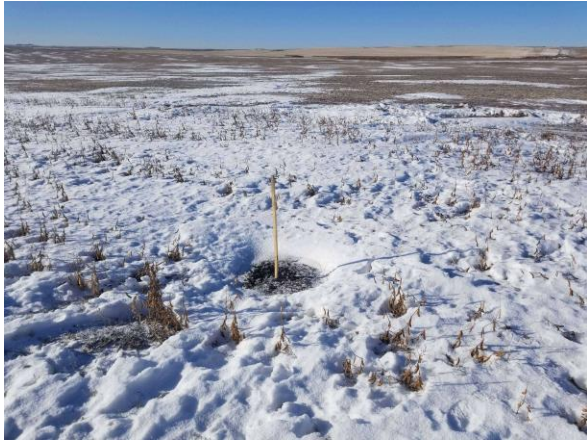
**Photo #1** View of borehole 1358-14 (1).

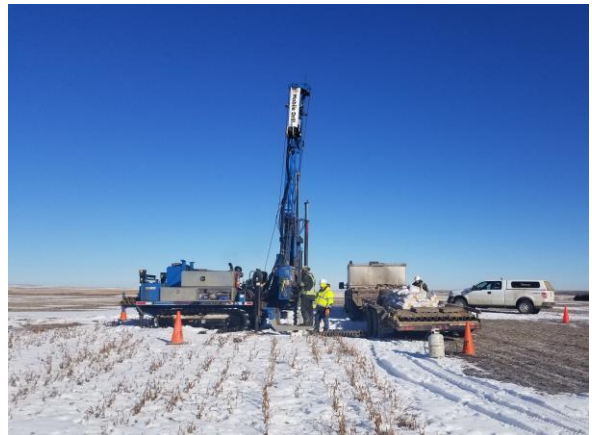
**Photo #2** Preparation of sealing borehole 1358-14 (1).

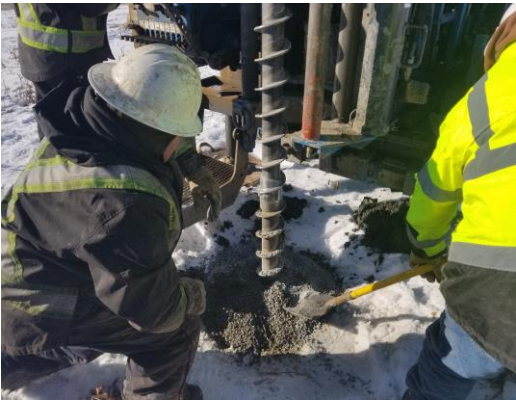
**Photo #3** View at borehole 1358-14 (1) backfilling with bentonite pellets.

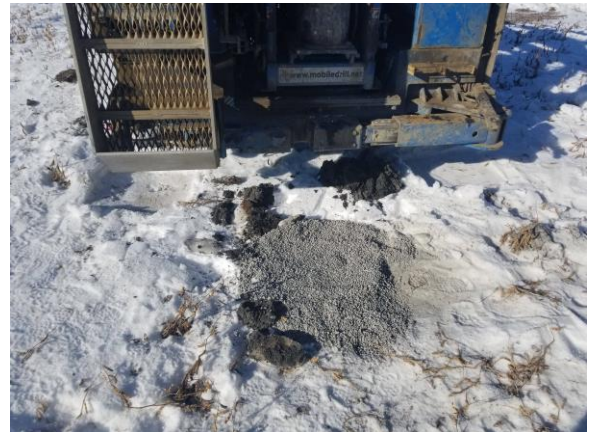
**Photo #4** View of completed sealing at borehole 1358-14 (1).

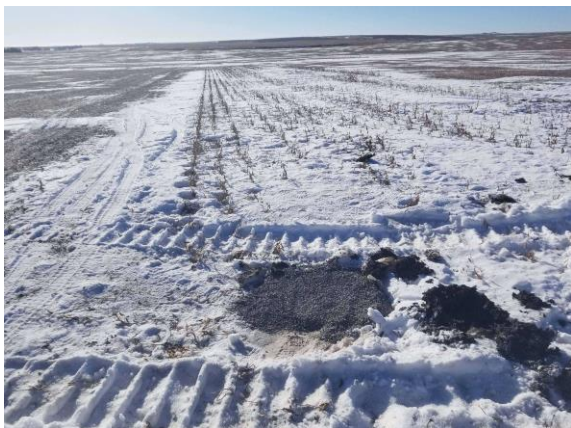
**Photo #5** View of completed sealing at borehole 1358-14 (1).

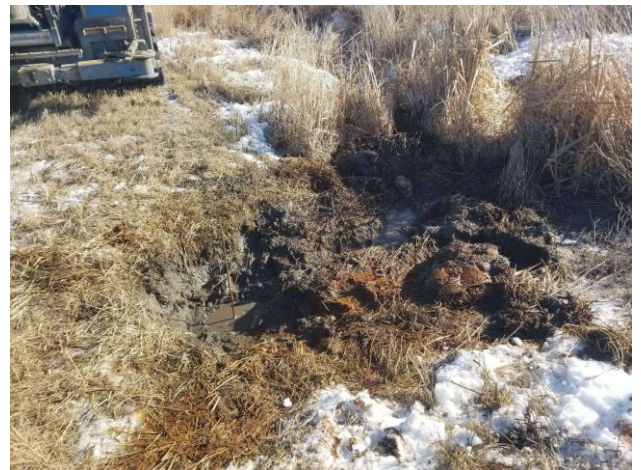
**Photo #6** View at borehole 1358-14 (2) – groundwater flowing.

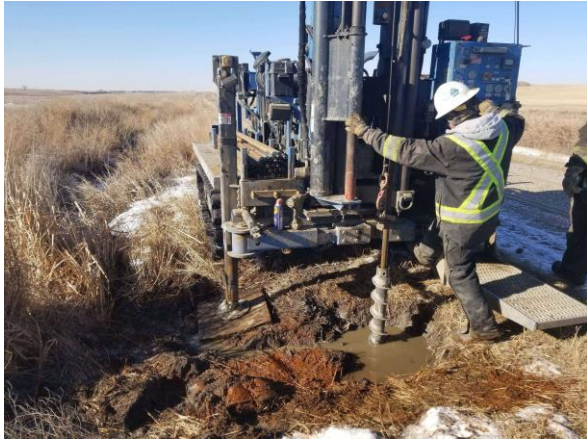
**Photo #7** Groundwater stopped flowing at approximately 19 feet bgs at 1358-14 (2).

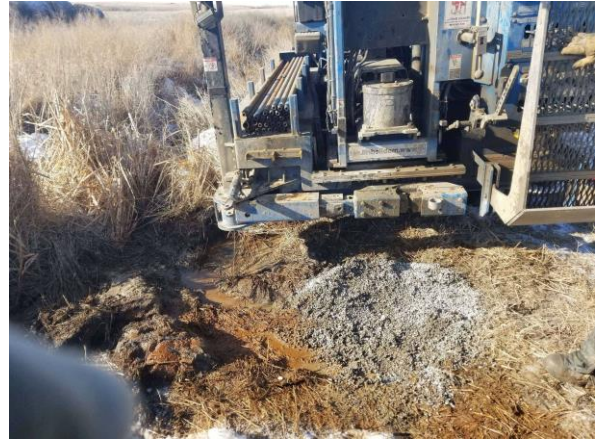
**Photo #8** Sealing completion at borehole 1358-14 (2).

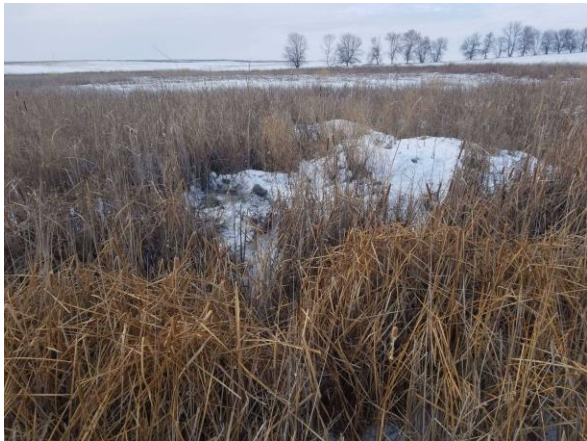
A third borehole was believed to exist to the north of 70<sup>th</sup> Street NW based on visual evidence of standing water, vegetation and interviews with the property owner. The land owner indicated that the borehole(s) was most likely located under one of three rockpiles. Terracon was present on January 30 & 31, 2020 to oversee excavation activities in an attempt to find the exact location of the borehole(s). A backhoe was utilized to dig trenches in generally north-south and east-west orientations under and around the rock piles. Each area was opened enough to allow for visual evidence of flowing water. At the time of the excavation activities, there was approximately two feet of frozen ground overlaying the saturated soil. In order to view waterflow, each trench was dug to approximately 2.5 feet below the natural ground surface (after rocks were removed). The natural surface water elevation was observed as frozen ponds and the underlying water appeared to be flowing through the saturated soil into the excavations. The deep-frozen ground with underlying saturated soils did not allow for observations of upwelling water flow. The

**Photo #9** View of one rock pile which may overlay the seismic borehole.

Based on the results, Terracon recommends no further action to boreholes 1358-14 (1) and 1358-14 (2). However, Terracon recommends continued observation of borehole 1358-14 (3) for evidence of flowing water.

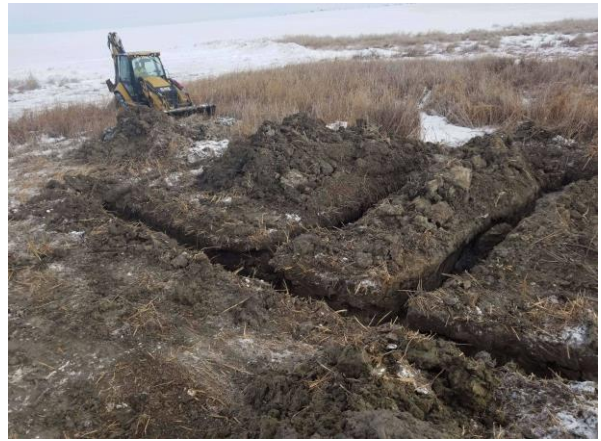
excavations were left open overnight to allow for the water to drain from the soil into the trenches in an effort to identify areas of continuously flowing or continuously draining water. Due to the surface and subsurface conditions during the excavation reconnaissance, Terracon was unable to pinpoint the exact location of the borehole at that time.

**Photo #10** View of excavated trench grid pattern for dewatering and looking for flow patterns.

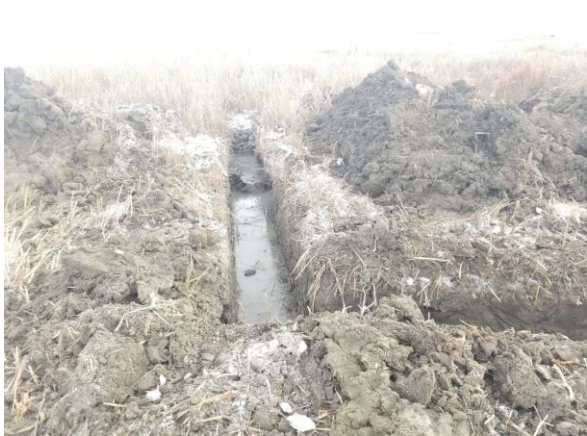
**Photo #11** View of water filling the excavation trenches.

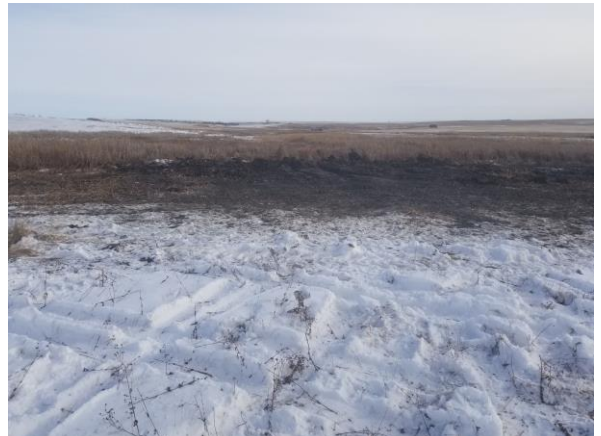
**Photo #12** View of leveled excavation area due to cave in and request of the landowner.
