Areas of Landslides

Kildeer 100K Sheet, North Dakota

Edward C. Murphy
2003

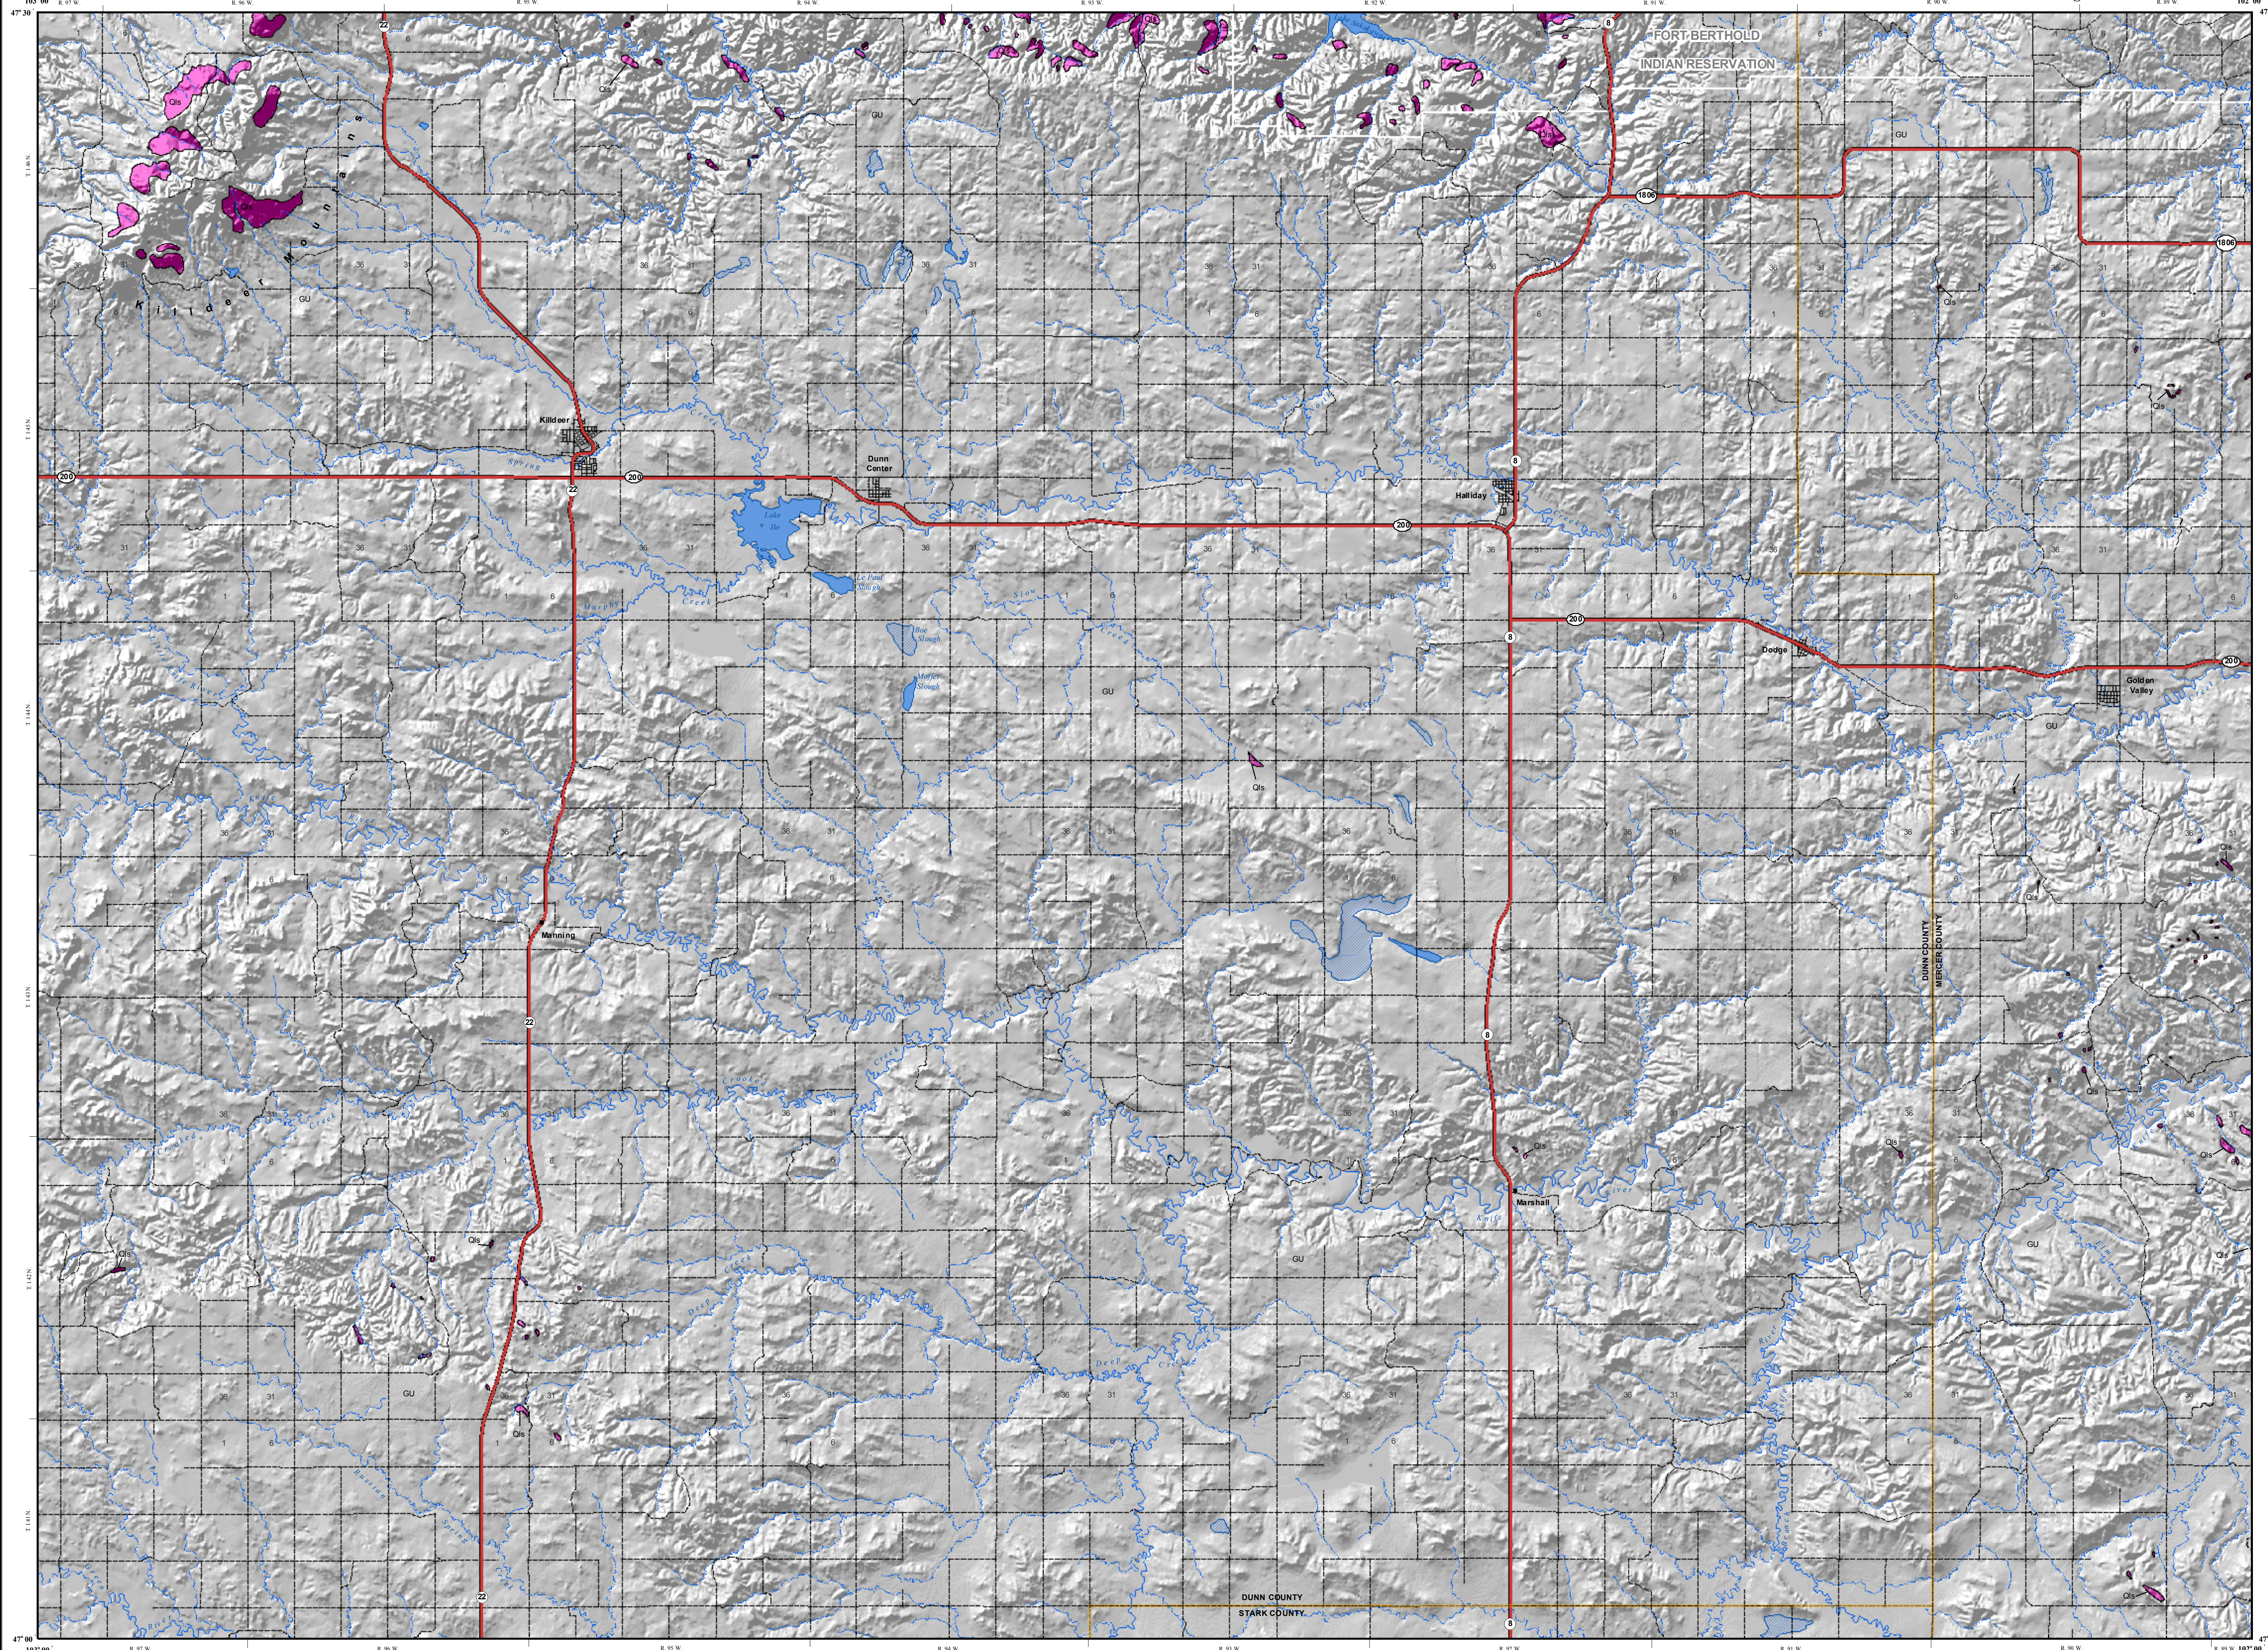
In this area, landslides are most prevalent within the Little Missouri River Badlands and the slopes of the Kildeer Mountains. The rocks in the Little Missouri River badlands are no different than those in the relatively stable badland topography north of the Crooked Creek Escarpment and the rugged topography along the eastern one-third of this sheet. Landslides are most prevalent along the Little Missouri River Valley because it was carved relatively quickly (in geologic terms) when glacial ice diverted the Little Missouri and Missouri River into these areas. Approximately 600,000 years ago, glaciers blocked the path of the north-flowing ancestral Little Missouri River near the west border of the North Unit of the Theodore Roosevelt National Park. The glacier forced the river to turn east and carve the steep, rugged badlands in this area. These steep slopes are very susceptible to landslides.

The Kildeer Mountains consist of two mesas. These mesas are erosional remnants of rocks that 25 million years ago (during Miocene time) were deposited across this map sheet. Tens of millions of years of erosion created the steep-sided slopes of the Kildeer Mountains. These slopes have failed by both rotational slumping and the calving of the well-cemented caprock.

Over 120 landslides were identified and are plotted on the Kildeer Sheet. These slides cover an area of 4,054 acres or less than one percent of the total land mass of this map. More locally, landslides occupy up to 30 or 40% of the Little Missouri River Badlands. Many of these slides are complexes that contain multiple landslides that may have occurred over a long period of time. The largest of these slide complexes occur in the Kildeer Mountains, approximately 600 acres in size, where roughly half of the slopes contain landslides. Although some landslides in the Little Missouri River Badlands may exceed 100 acres, most slides on this sheet extend over an area of less than 20 acres. Most of these landslides are well-vegetated indicating they are quite old, perhaps tens, if not hundreds, of thousands of years old in the Little Missouri River Badlands; occurring relatively quickly after the steep-sided slopes had formed. Careful consideration is required prior to construction to avoid landslide prone areas in the Little Missouri River Badlands and the slopes of the Kildeer Mountains.

A mass of sediment and/or rock that have slid or tumbled down slope. A pink area on the map may represent dozens of individual landslides.
