Areas of Landslides

Oriska Quadrangle, North Dakota

**Christopher A. Maike
&
Fred J. Anderson**

2022

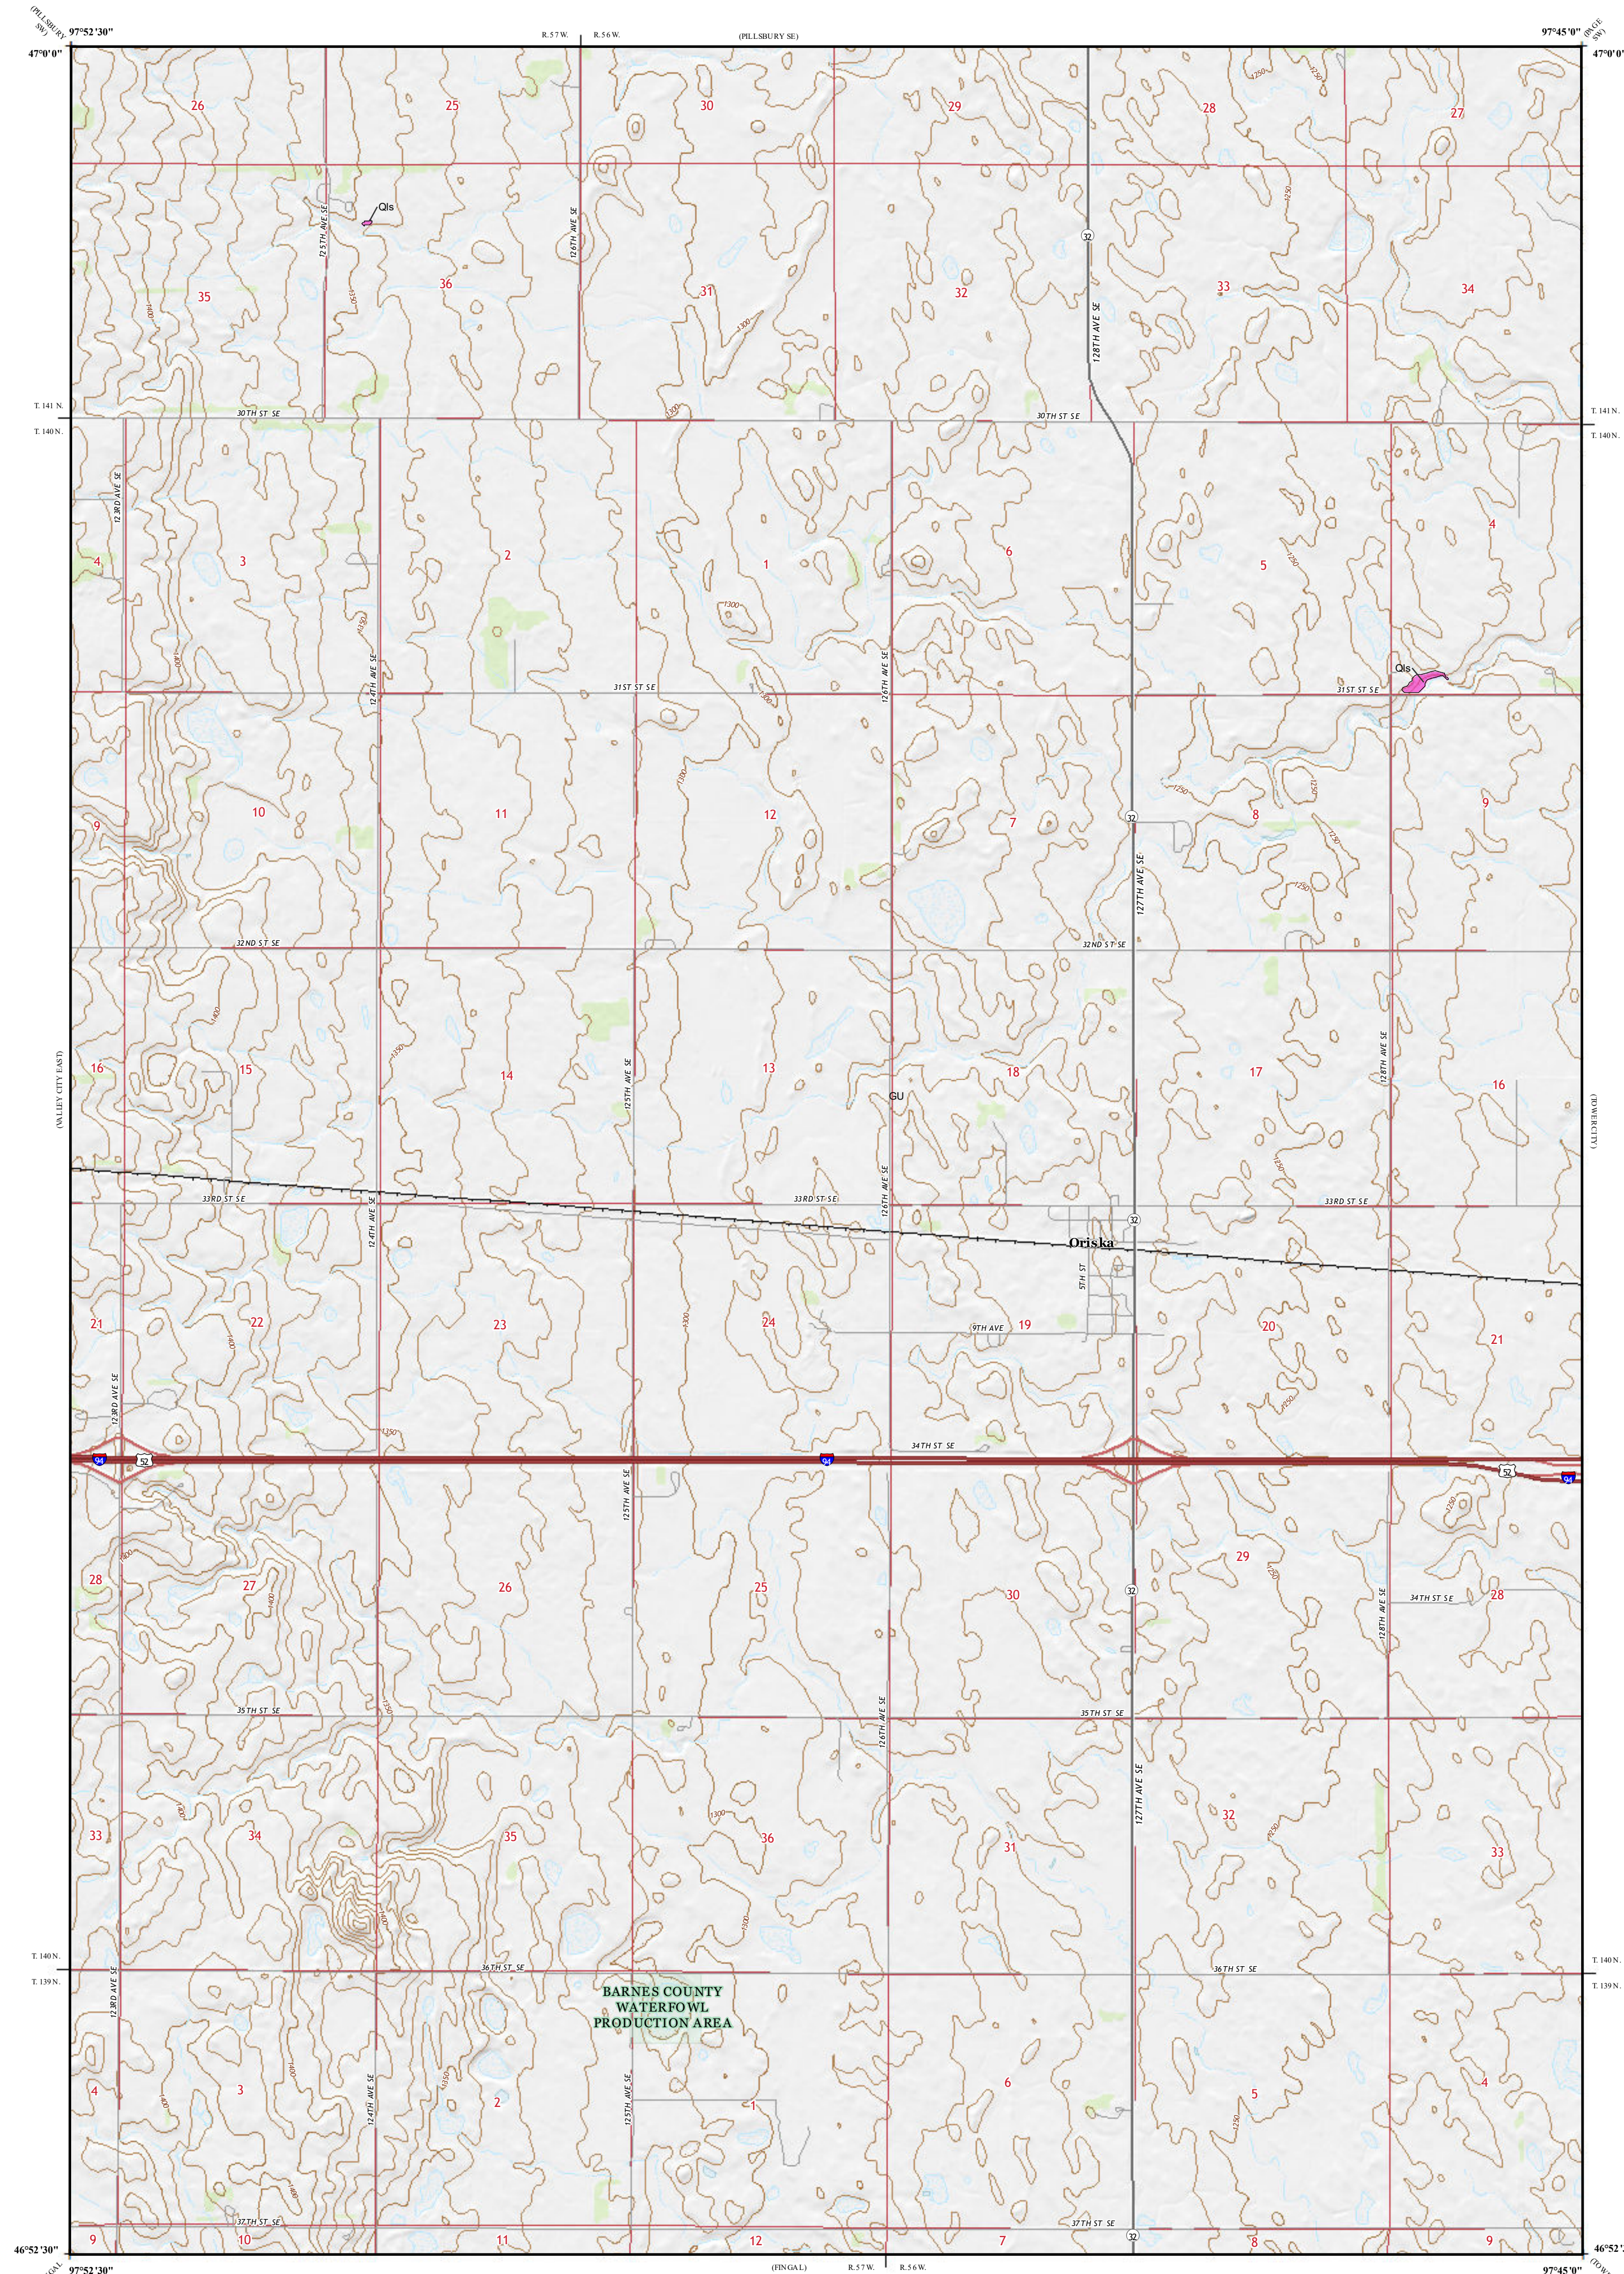
Oriska Quadrangle, North Dakota

Qls Landslide Deposits

A mass of material that has moved downslope. Includes earth flows, slumps, and areas of soil creep.

Landslides identified on this quadrangle were mapped from stereo pairs, black and white 1:20,000 scale aerial photographs flown in August 1959 by the United States Department of Agriculture (USDA). Additional data sources include digital orthophotography from the USDA National Agriculture Imagery Program (NAIP) flown in September to October 2021 and the North Dakota Geological Survey LiDAR Map Series, which compiles raw data flown in May to June 2019 from the North Dakota State Water Commission. Landslide mapping originally completed by Anderson in 2021 has been updated on this map after reviewing recently published LiDAR elevation data and contemporary imagery.
