Areas of Landslides Garrison Quadrangle, North Dakota

2023

Garrison Quadrangle, North Dakota

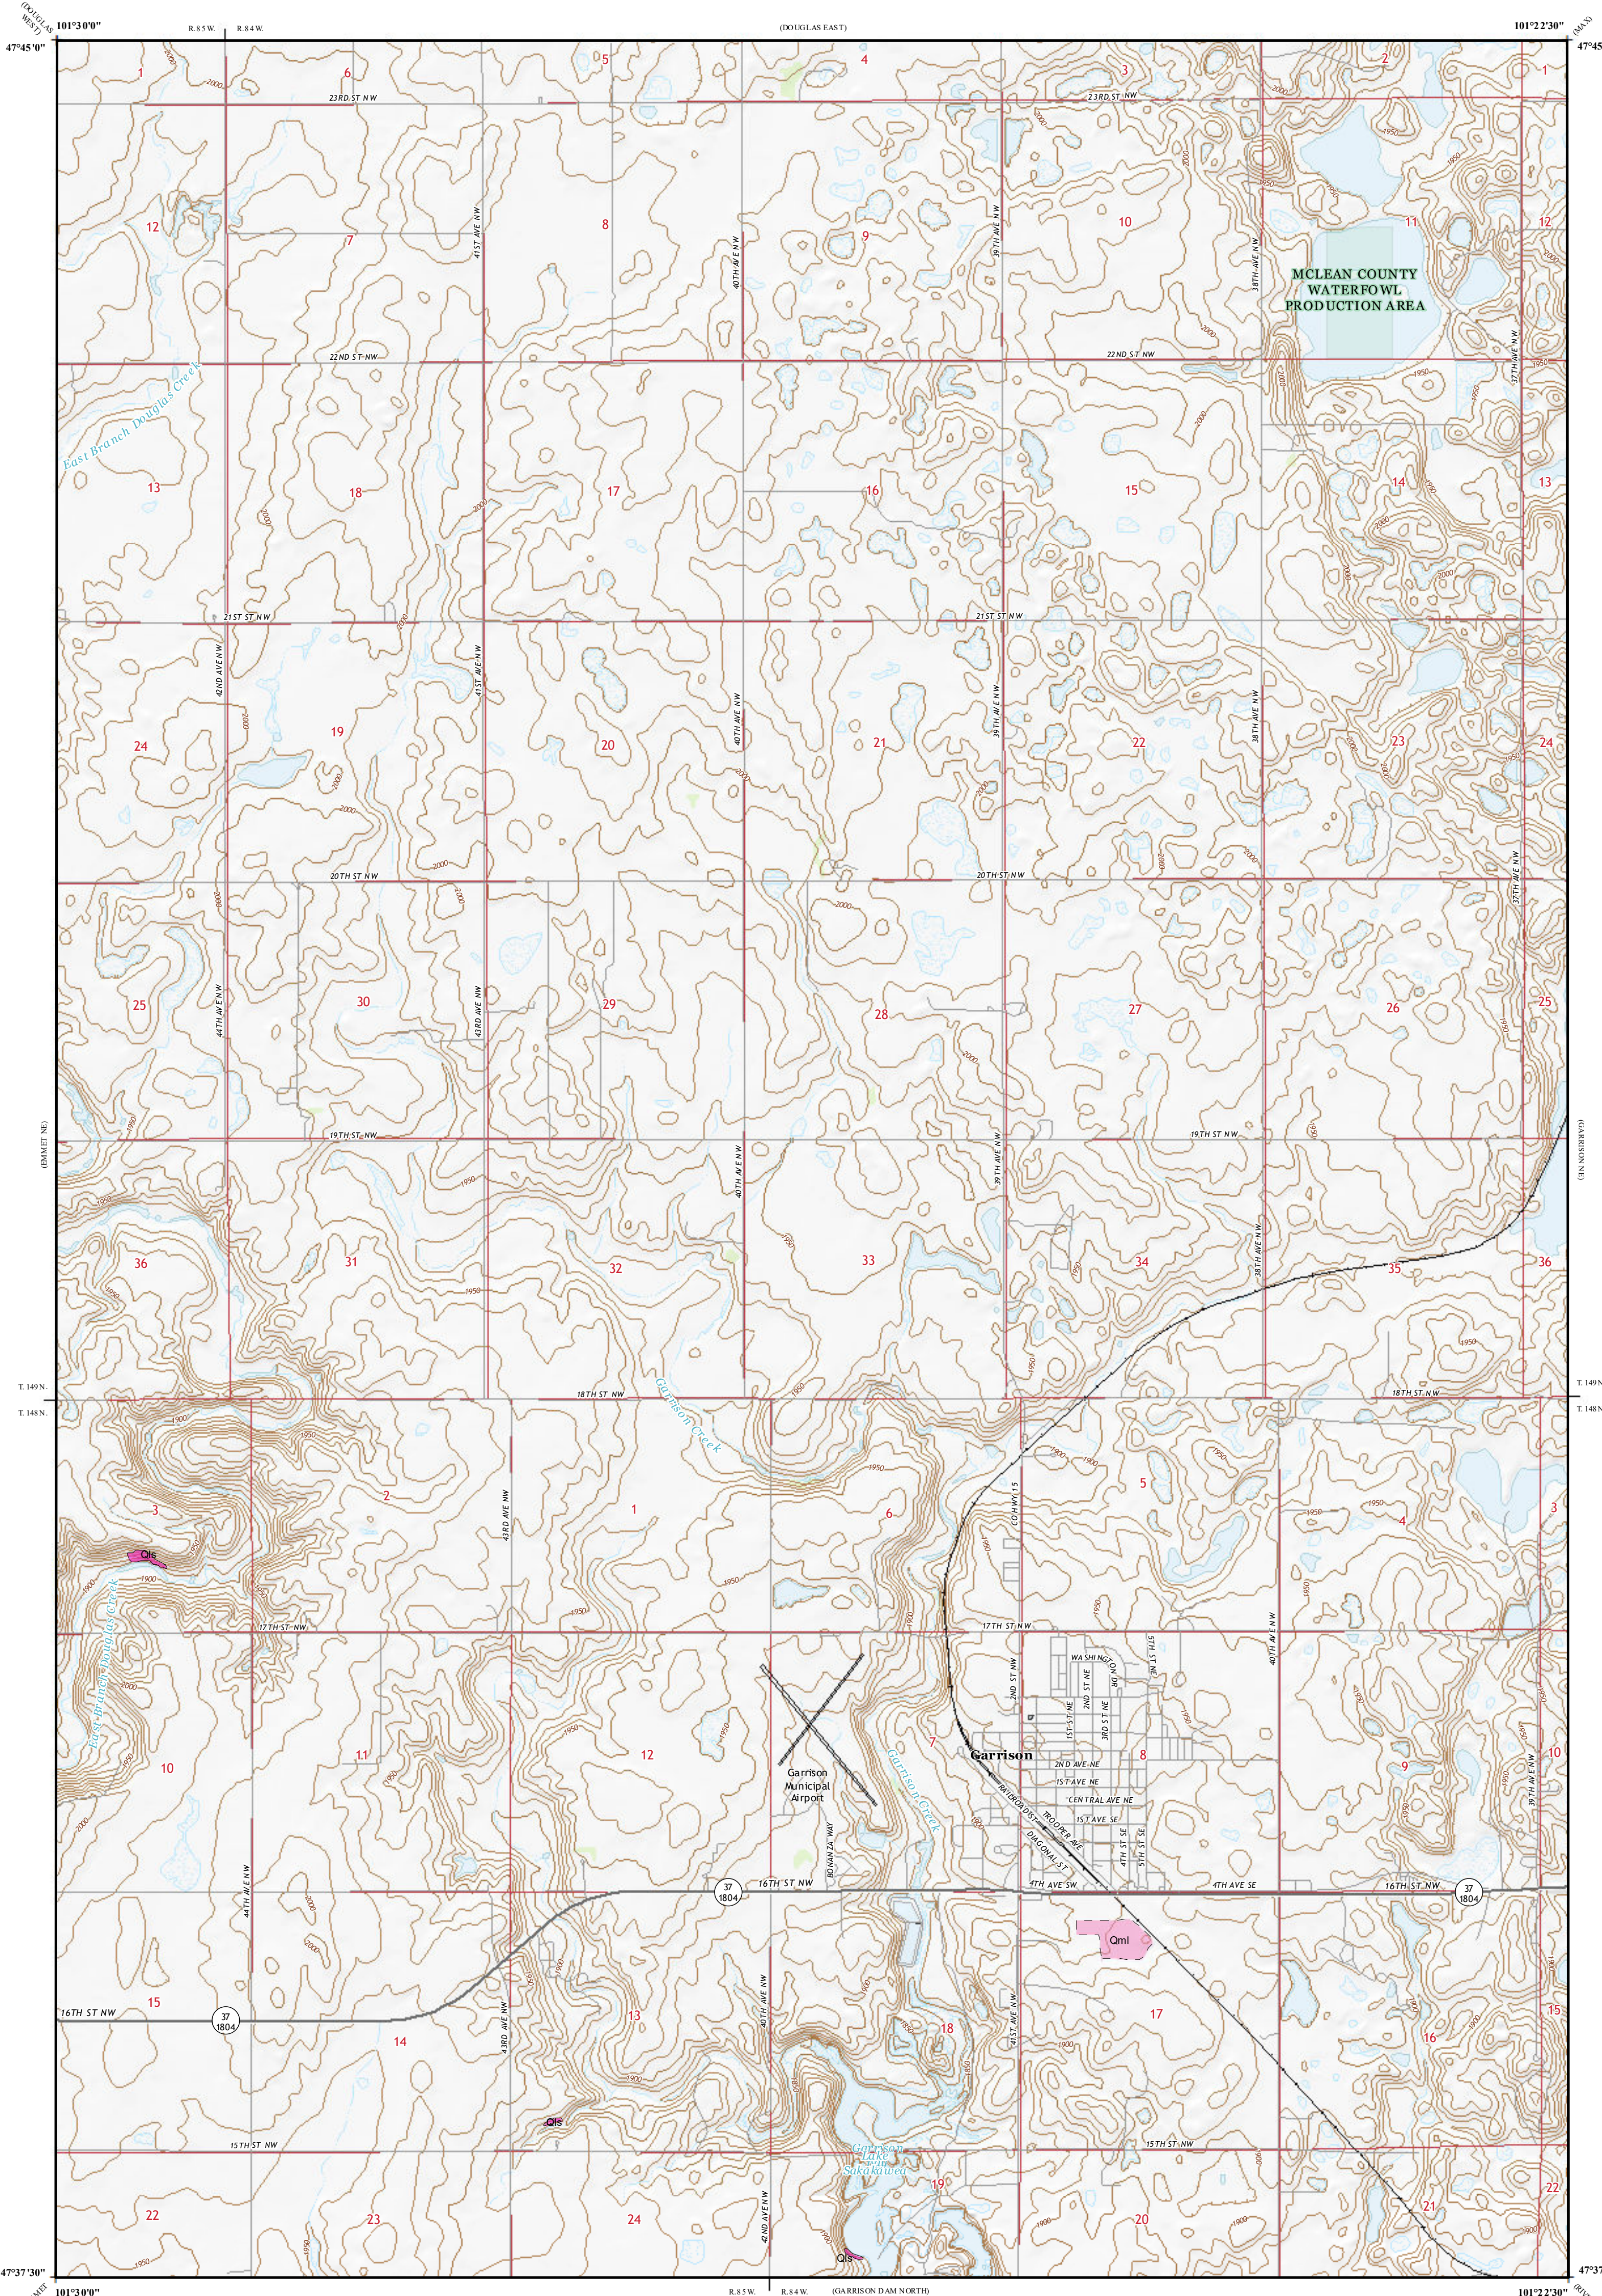
A mass of material that has moved downslope. Includes earth flows, slumps, and areas of soil creep.

Surface underlain by voids created by the underground mining of lignite. Collapse of the mine voids often creates sinkholes or depressions at the surface.

Landslides identified on this quadrangle were mapped from stereo pairs, black and white 1:20,000 scale aerial photographs flown in 1958 by the United States Department of Agriculture (USDA). Additional data sources include digital orthophotography from the USDA National Agriculture Imagery Program (NAIP) flown in August to October 2021 and the North Dakota Geological Survey LiDAR Map Series, which compiles raw data flown in October 2021 from the North Dakota State Water Commission.
