Areas of Landslides

Hurricane Lake East Quadrangle, North Dakota

Christopher A. Maike

2023

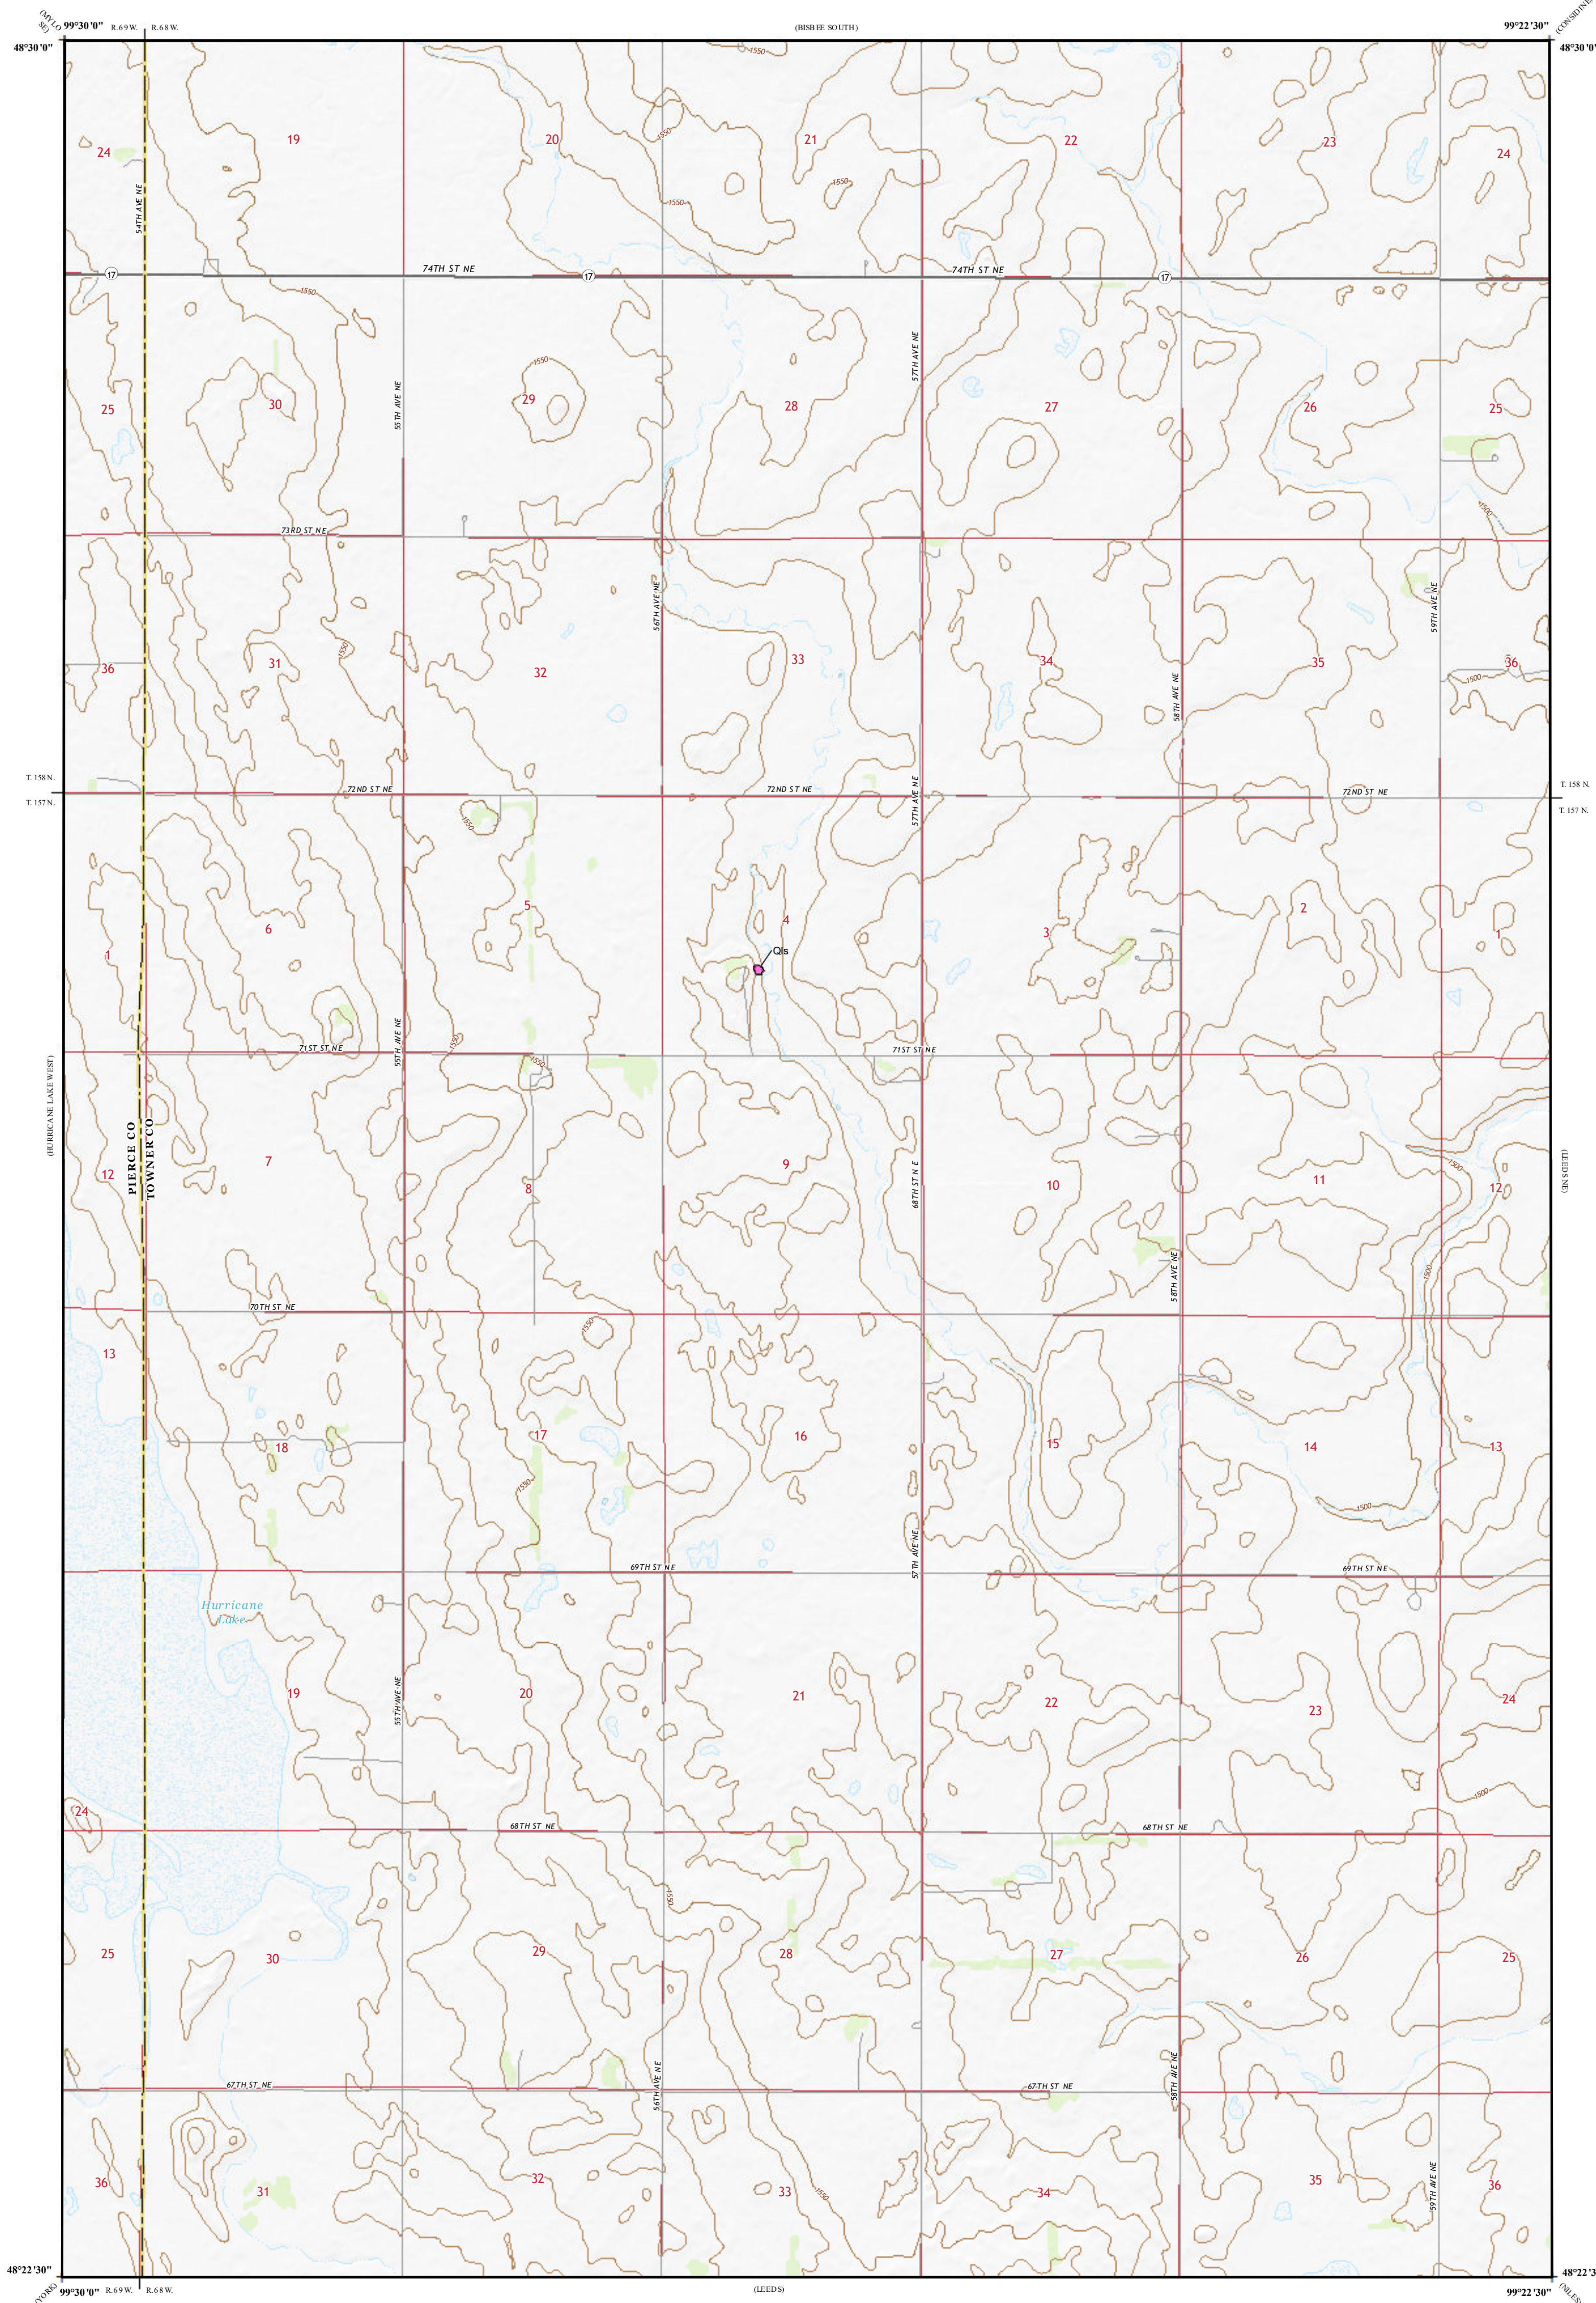
Hurricane Lake East Quadrangle, North Dakota

Qls Landslide Deposits

A mass of material that has moved downslope. Includes earth flows, slumps, and areas of soil creep.

Landslides identified on this quadrangle were mapped from stereo pairs, black and white 1:20,000 scale aerial photographs flown in July 1957 by the United States Department of Agriculture (USDA). Additional data sources include digital orthophotography from the USDA National Agriculture Imagery Program (NAIP) flown in October 2021 and the North Dakota Geological Survey LiDAR Map Series, which compiles raw data flown in November 2020 from the North Dakota State Water Commission.
