# Areas of Landslides

## Bathgate Quadrangle, North Dakota

**Benjamin C. York  
&  
Christopher A. Maike**

**2023**

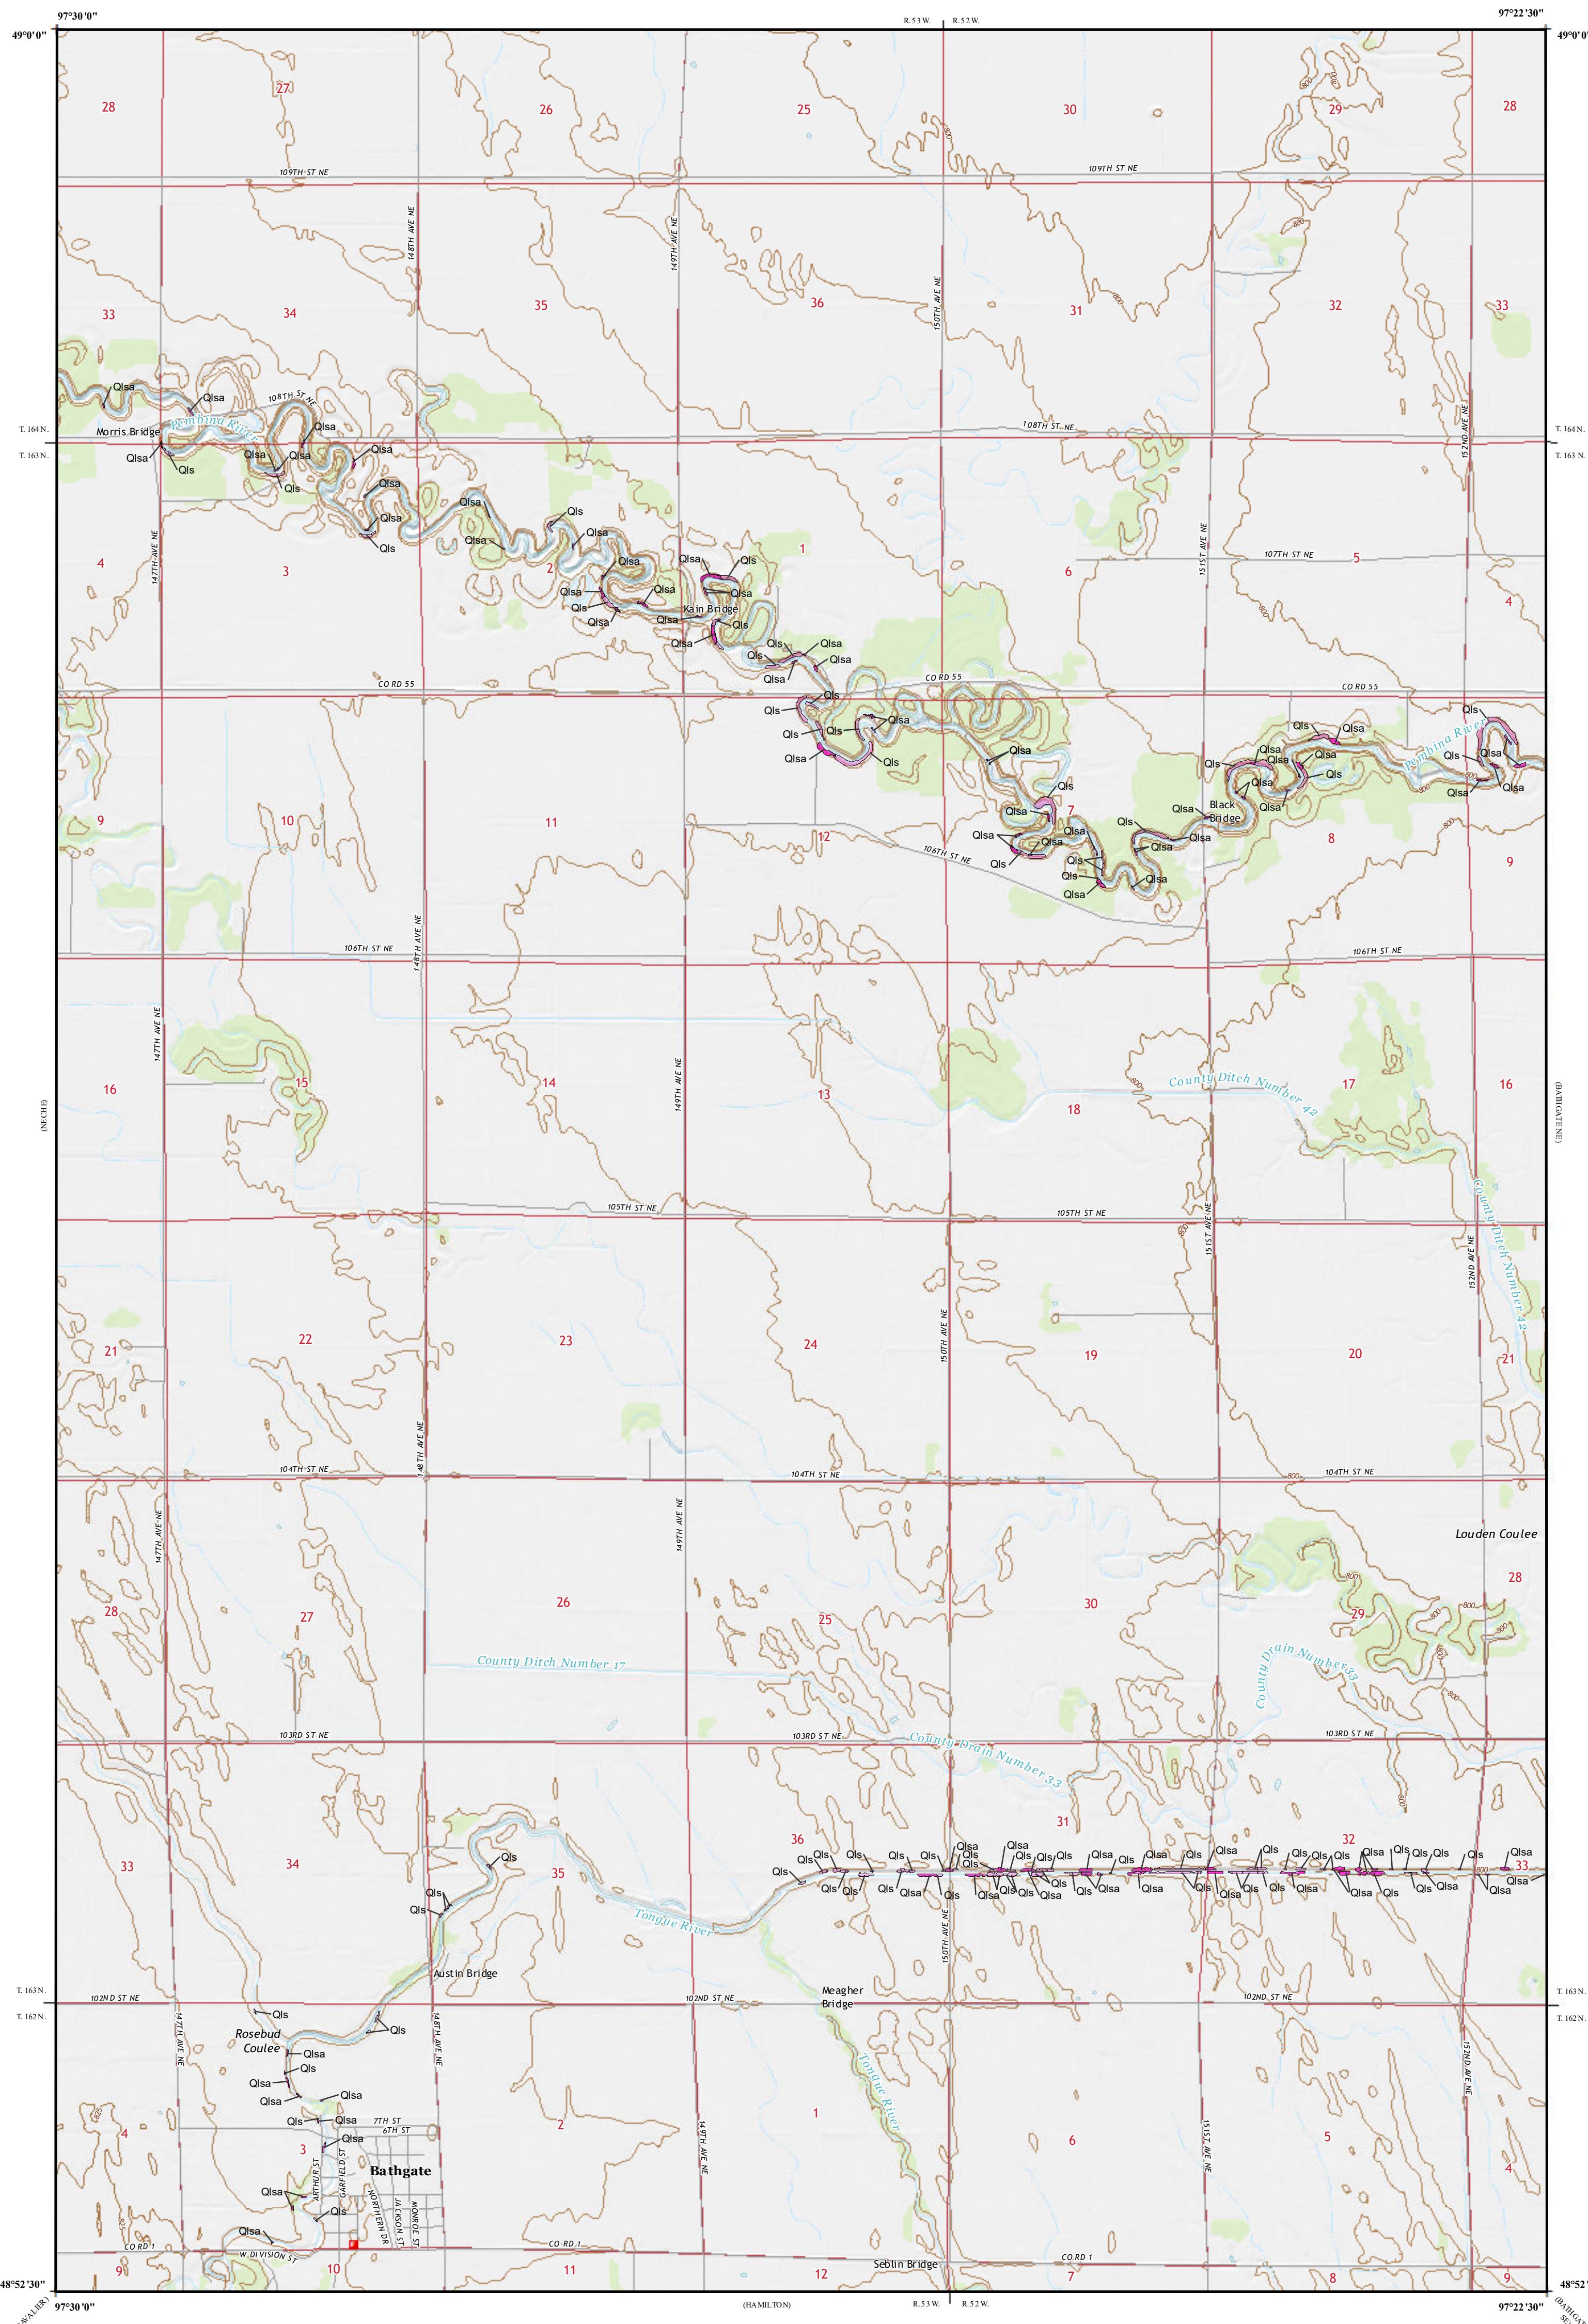
Bathgate Quadrangle, North Dakota

#### Qlsa Areas of Recently Active Landslides

Landslide areas showing movement between 2008 and 2018.

#### Qls Landslide Deposits

A mass of material that has moved downslope. Includes earth flows, slumps, and areas of soil creep.

Landslides identified on this quadrangle were mapped from stereo pairs, black and white 1:20,000 scale aerial photographs flown in 1962 by the United States Department of Agriculture (USDA). Additional data sources include digital orthophotography from the USDA National Agriculture Imagery Program (NAIP) flown in September 2021 and the North Dakota Geological Survey LiDAR Map Series, which compiles raw data flown in May 2017 to May 2018 from the North Dakota State Water Commission.

Areas of recently active landslides (Qlsa) mapped on this quadrangle were identified from changes between the 2008 and 2018 LiDAR elevation datasets observed on an elevation subtraction raster. Noise introduced from data precision (typically within a foot between the LiDAR datasets) is removed on this raster by excluding the signal from elevation change in the +/- 1 foot interval. Geologists interpret areas of landslide movement in geomorphic context (typically a decrease in elevation near a landslide headscarp paired with an increase in elevation downslope near the toe) and delineate those areas within the larger landslide dataset. Landslides not identified as recently active may have also experienced movement relatively recently, but did not show discernible signs of movement during the 2008 to 2018 window between LiDAR collects.

Slope Failure Statistical Summary				
Map Unit	No. of Landslides	Mapped Landslide Area		Map Area %
		acres	m <sup>2</sup>	
Total Landslides (Qls & Qlsa)	157	41	165,090	0.1
Recently Active Landslides (Qlsa)	83	14	55,400	0.04

33.56% of the mapped landslide area was active between 2008 and 2018
