Areas of Landslides Cavalier Quadrangle, North Dakota

**Benjamin C. York
&
Christopher A. Maike**

2023

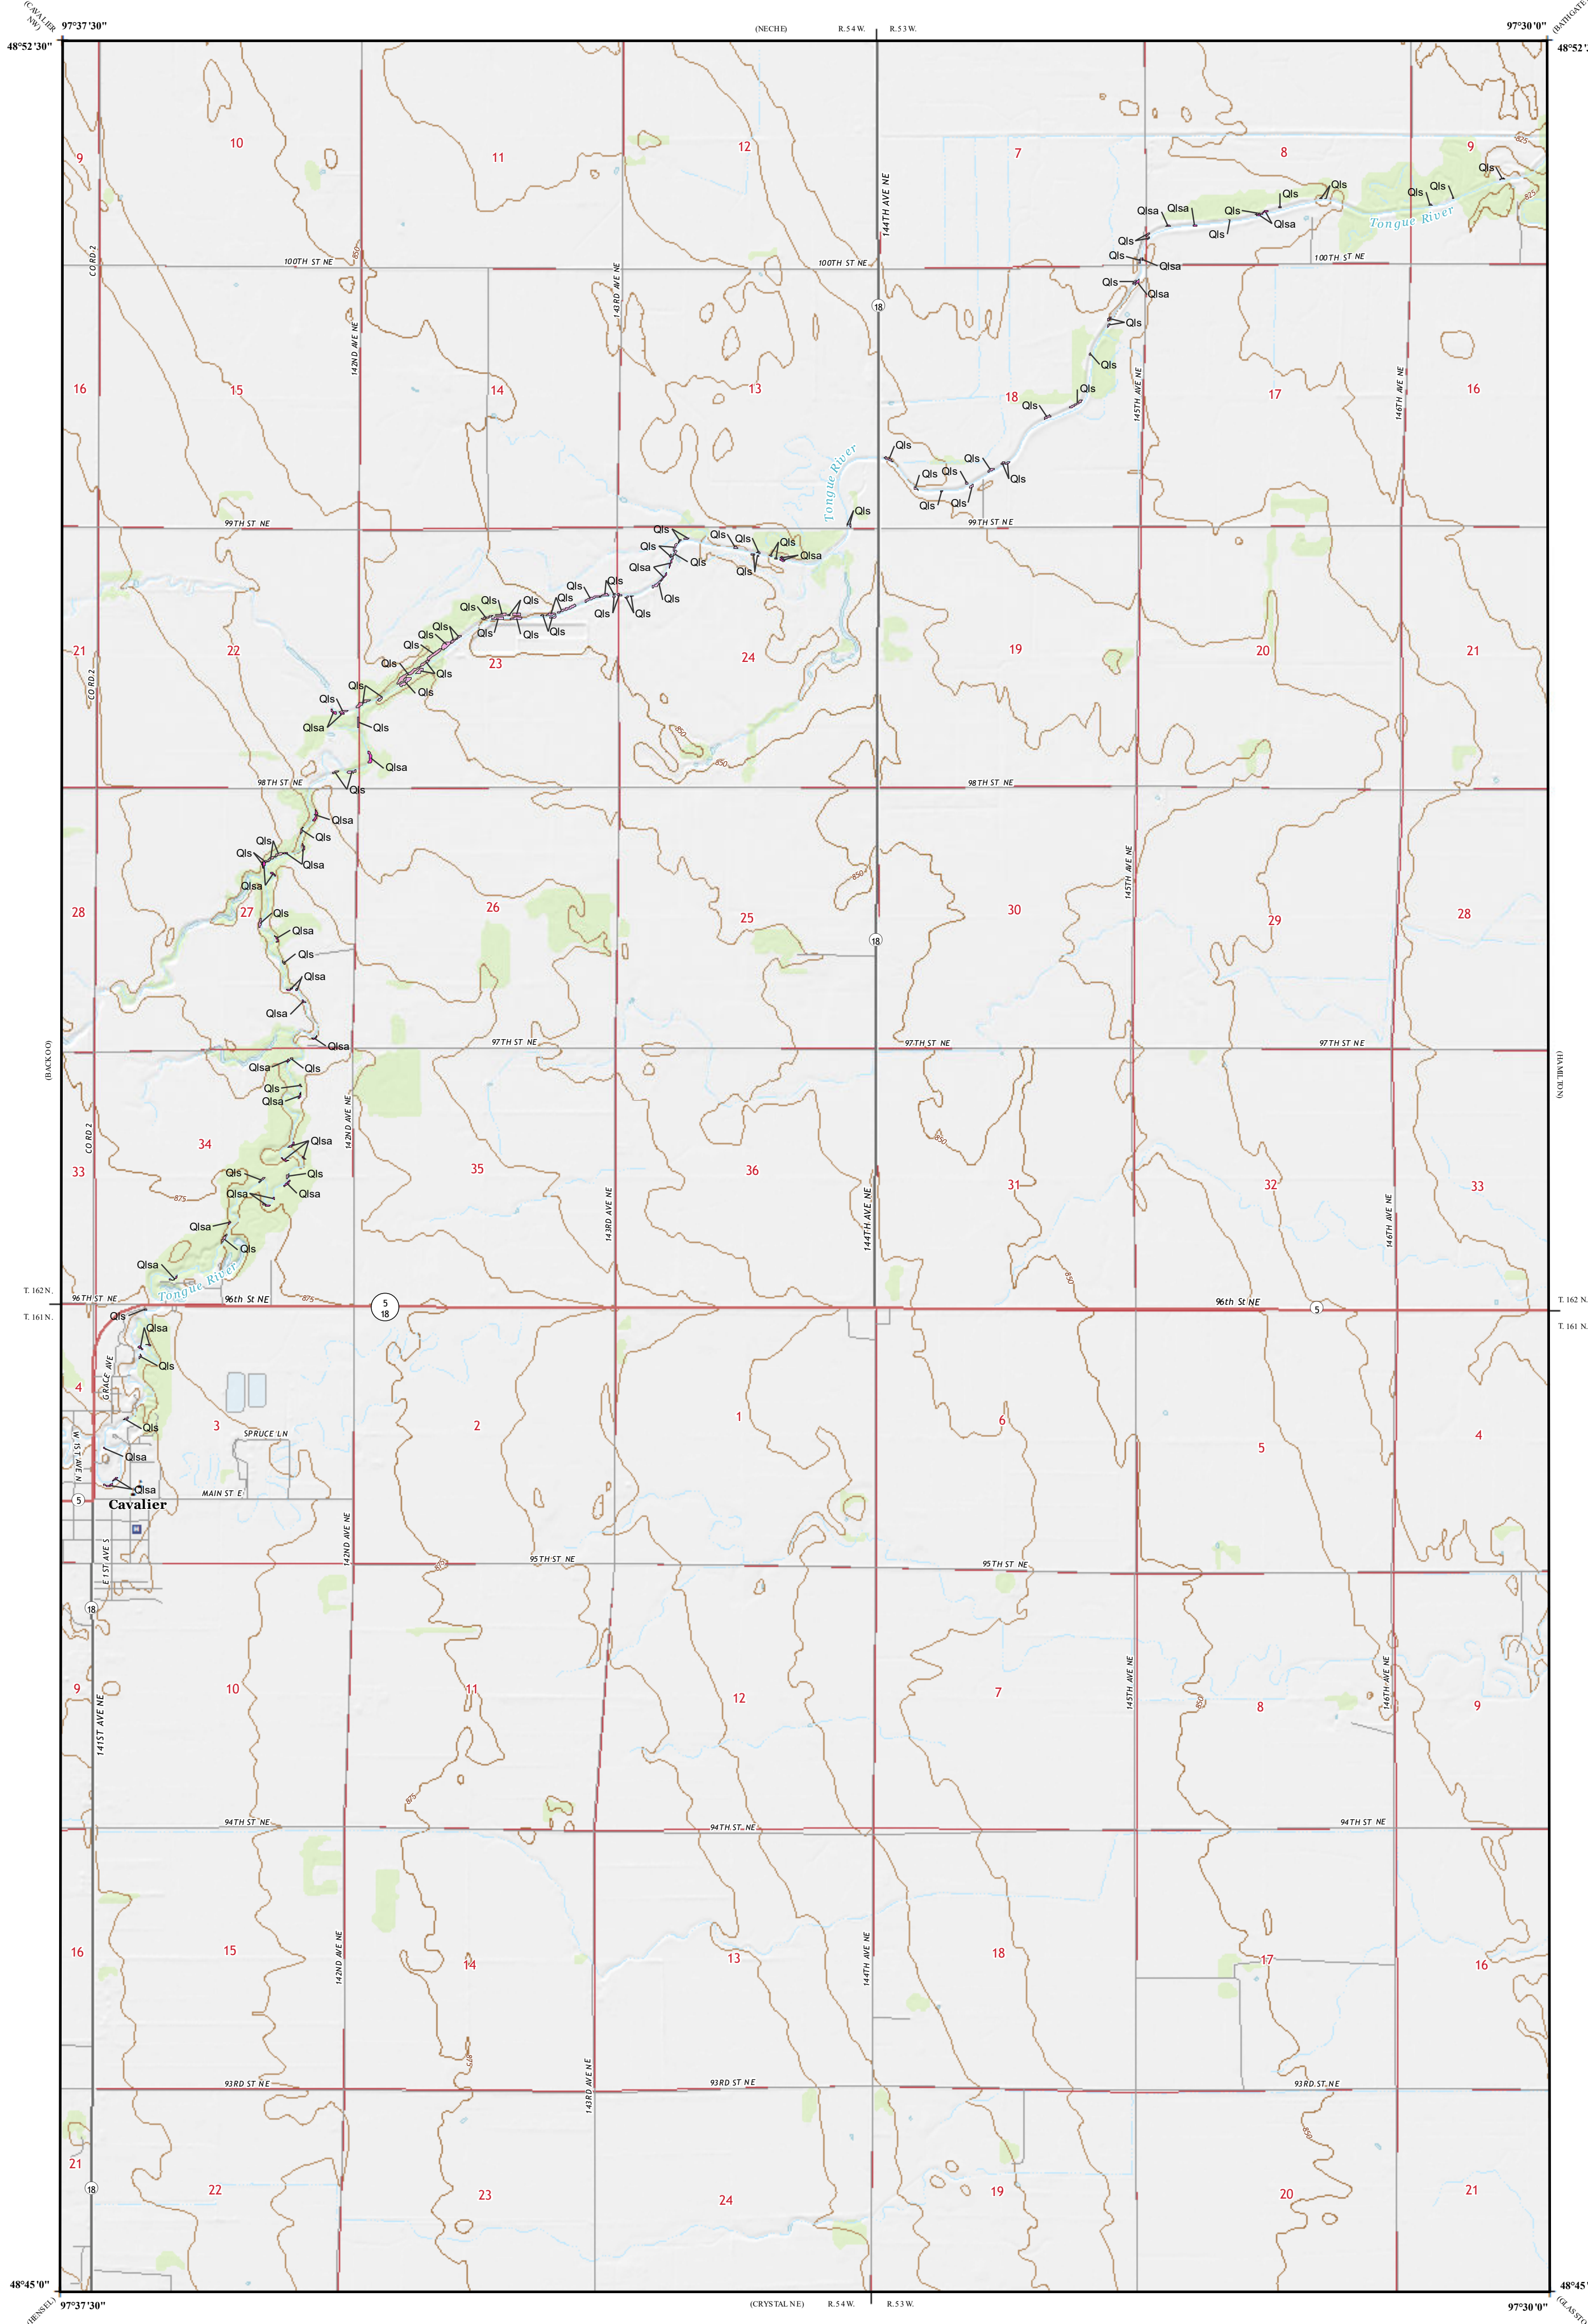
Cavalier Quadrangle, North Dakota

Qlsa Areas of Recently Active Landslides

Landslide areas showing movement between 2008 and 2017.

Qls Landslide Deposits

A mass of material that has moved downslope. Includes earth flows, slumps, and areas of soil creep.

Landslides identified on this quadrangle were mapped from stereo pairs, black and white 1:20,000 scale aerial photographs flown in 1962 by the United States Department of Agriculture (USDA). Additional data sources include digital orthophotography from the USDA National Agriculture Imagery Program (NAIP) flown in September 2021 and the North Dakota Geological Survey LiDAR Map Series, which compiles raw data flown in May 2017 from the North Dakota State Water Commission.

Areas of recently active landslides (Qlsa) mapped on this quadrangle were identified from changes between the 2008 and 2017 LiDAR elevation datasets observed on an elevation subtraction raster. Noise introduced from data precision (typically within a foot between the LiDAR datasets) is removed on this raster by excluding the signal from elevation change in the +/- 1 foot interval. Geologists interpret areas of landslide movement in geomorphic context (typically a decrease in elevation near a landslide headscarp paired with an increase in elevation downslope near the toe) and delineate those areas within the larger landslide dataset. Landslides not identified as recently active may have also experienced movement relatively recently, but did not show discernable signs of movement during the 2008 to 2017 window between LiDAR collects.

Slope Failure Statistical Summary				
Map Unit	No. of Landslides	Mapped Landslide Area		Map Area %
		acres	m ²	
Total Landslides (Qls & Qlsa)	122	12	49,060	0.03
Recently Active Landslides (Qlsa)	38	3	11,572	0.01

23.56% of the mapped landslide area was active between 2008 and 2017
