Areas of Landslides

Leroy Quadrangle, North Dakota

**Benjamin C. York
&
Fred J. Anderson**

2023

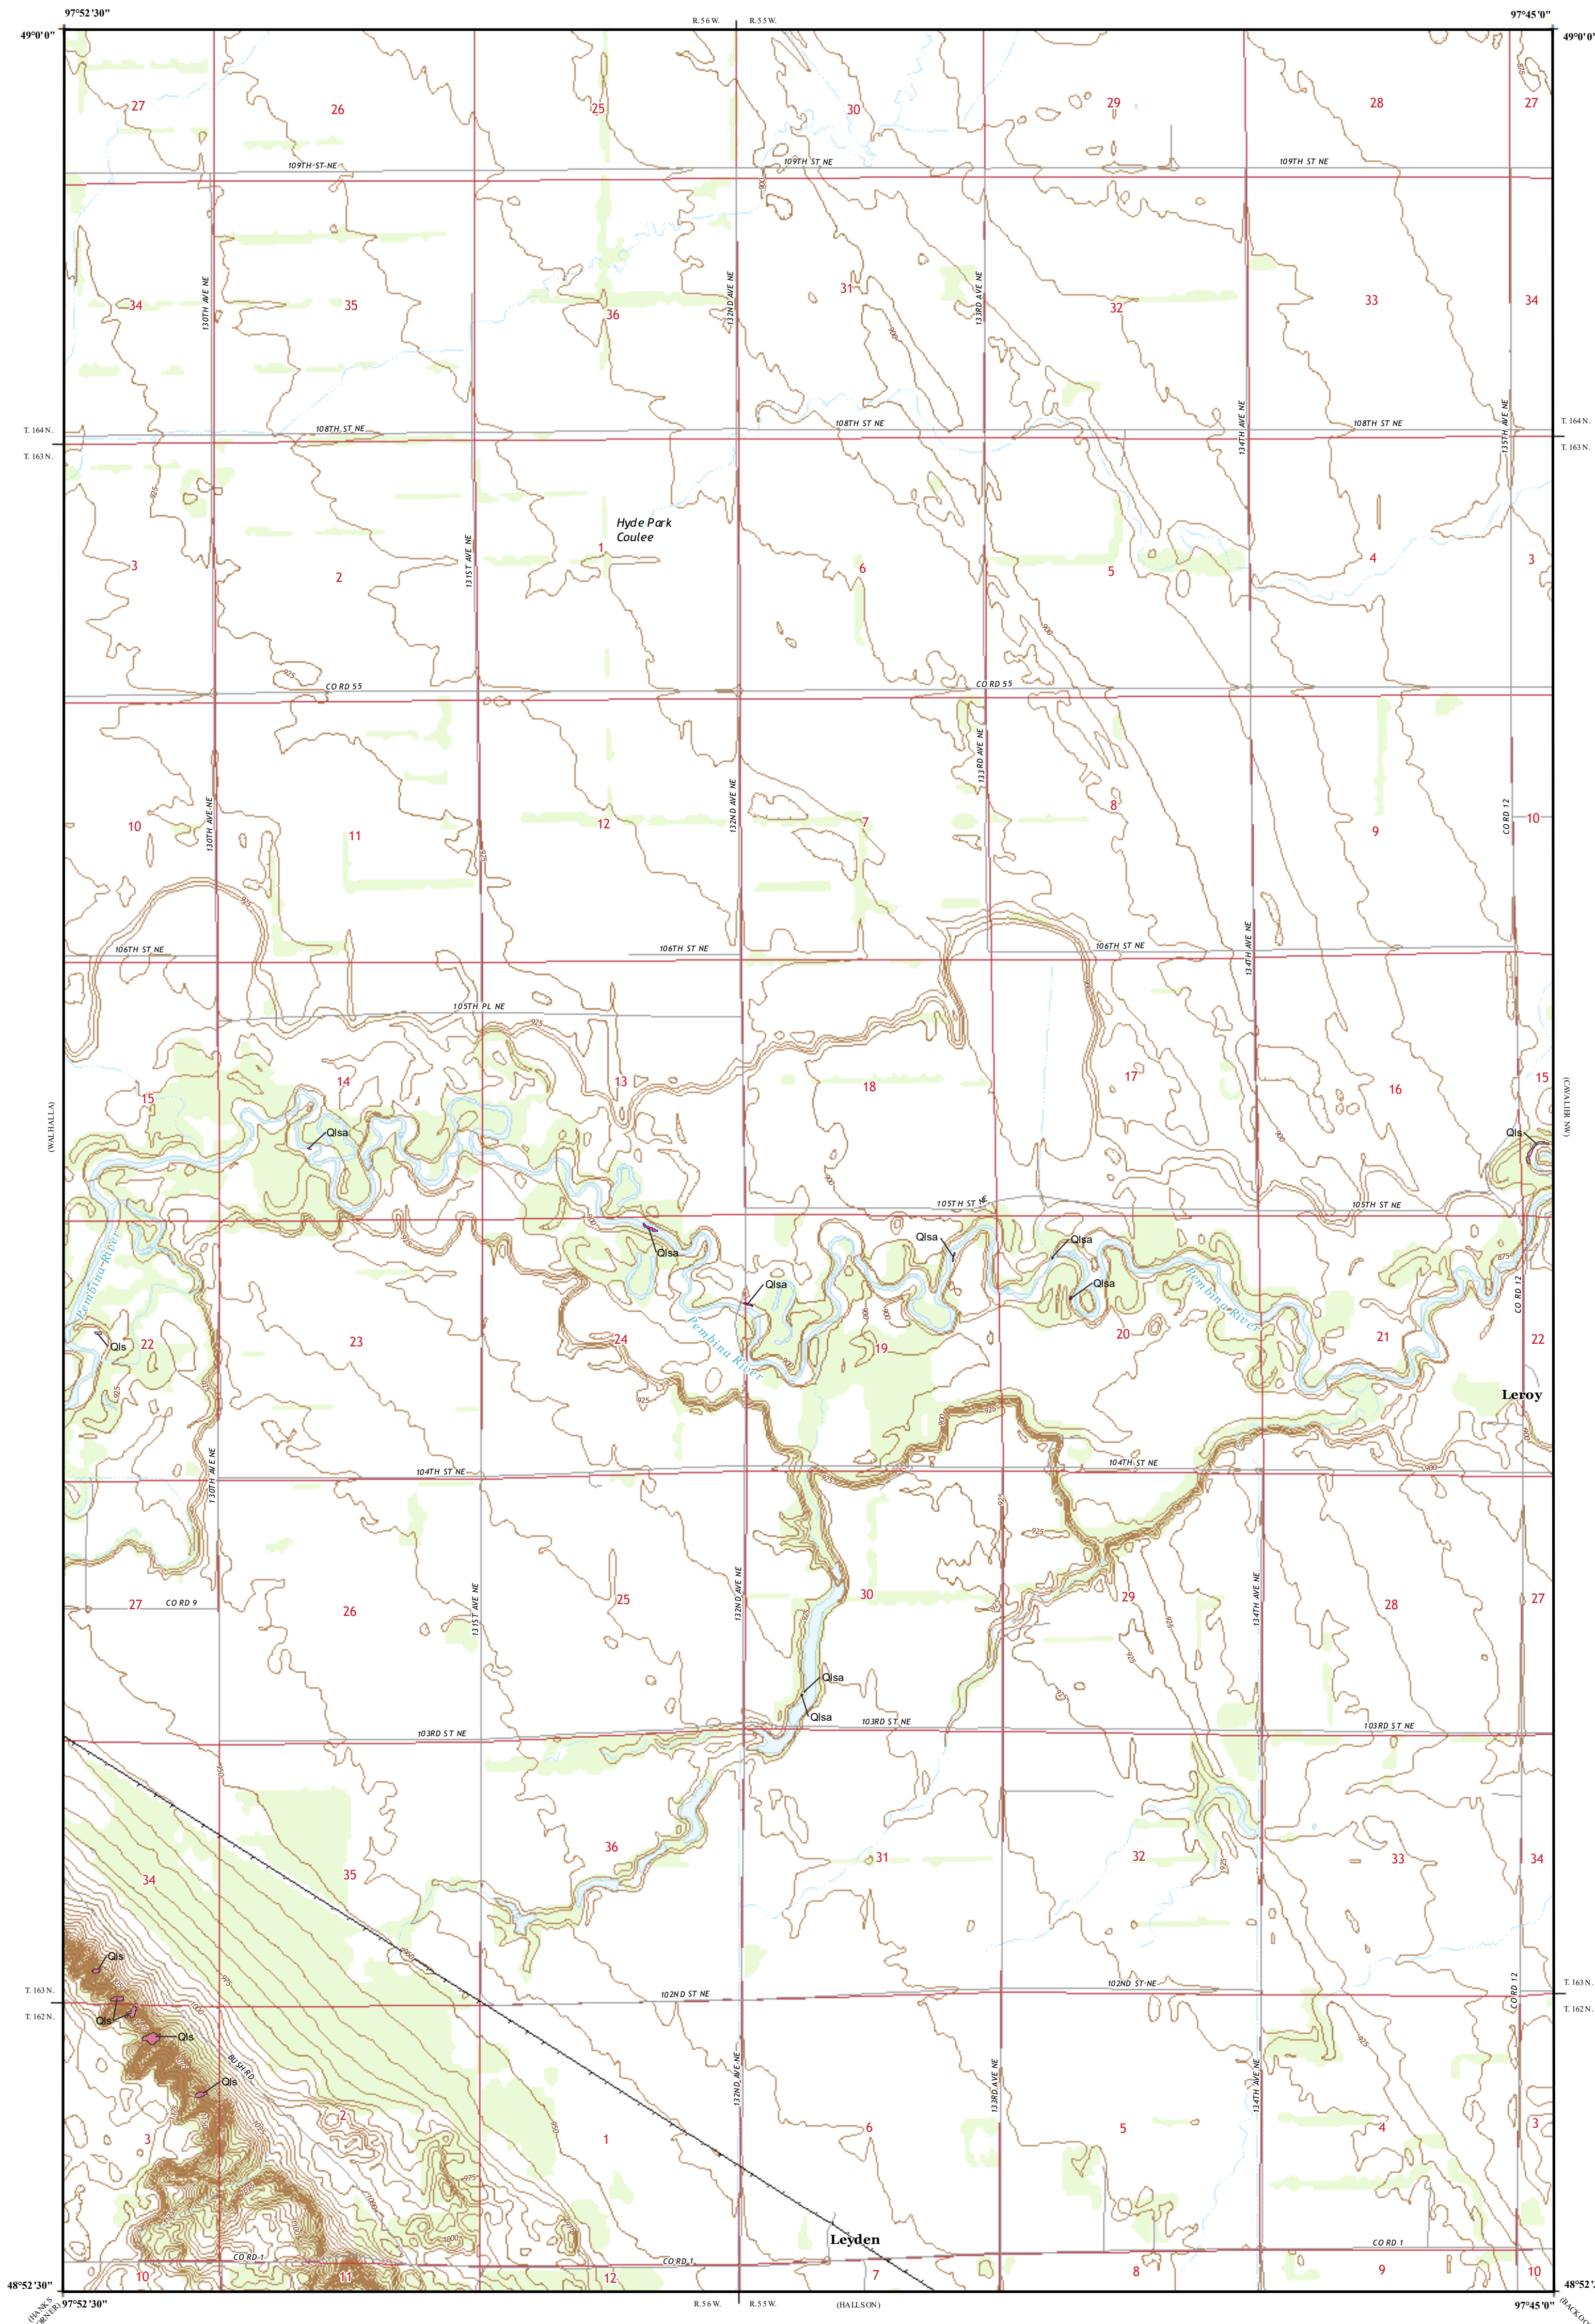
Qlsa Areas of Recently Active Landslides

Landslide areas showing movement between 2008 and 2017.

Qls Landslide Deposits

A mass of material that has moved downslope. Includes earth flows, slumps, and areas of soil creep.

Landslides identified on this quadrangle were mapped from stereo pairs, black and white 1:20,000 scale aerial photographs flown in September 1962 by the United States Department of Agriculture (USDA). Additional data sources include digital orthophotography from the USDA National Agriculture Imagery Program (NAIP) flown in September 2021 and the North Dakota Geological Survey LiDAR Map Series, which compiles raw data flown in May 2017 from the North Dakota State Water Commission.

Areas of recently active landslides (Qlsa) mapped on this quadrangle were identified from changes between the 2008 and 2017 LiDAR elevation datasets observed on an elevation subtraction raster. Noise introduced from data precision (typically within a foot between the LiDAR datasets) is removed on this raster by excluding the signal from elevation change in the +/- 1 foot interval. Geologists interpret areas of landslide movement in geomorphic context (typically a decrease in elevation near a landslide headscarp paired with an increase in elevation downslope near the toe) and delineate those areas within the larger landslide dataset. Landslides not identified as recently active may have also experienced movement relatively recently, but did not show discernible signs of movement during the 2008 to 2017 window between LiDAR collects.

Slope Failure Statistical Summary				
Map Unit	No. of Landslides	Mapped Landslide Area		Map Area %
		acres	m ²	
Total Landslides (Qls & Qlsa)	15	4	17,934	0.01
Recently Active Landslides (Qlsa)	8	1	2,497	0.002
14% of the mapped landslide area was active between 2008 and 2017
