# Areas of Landslides

## Garrison Dam North Quadrangle, North Dakota

**Christopher A. Maike**

**2023**

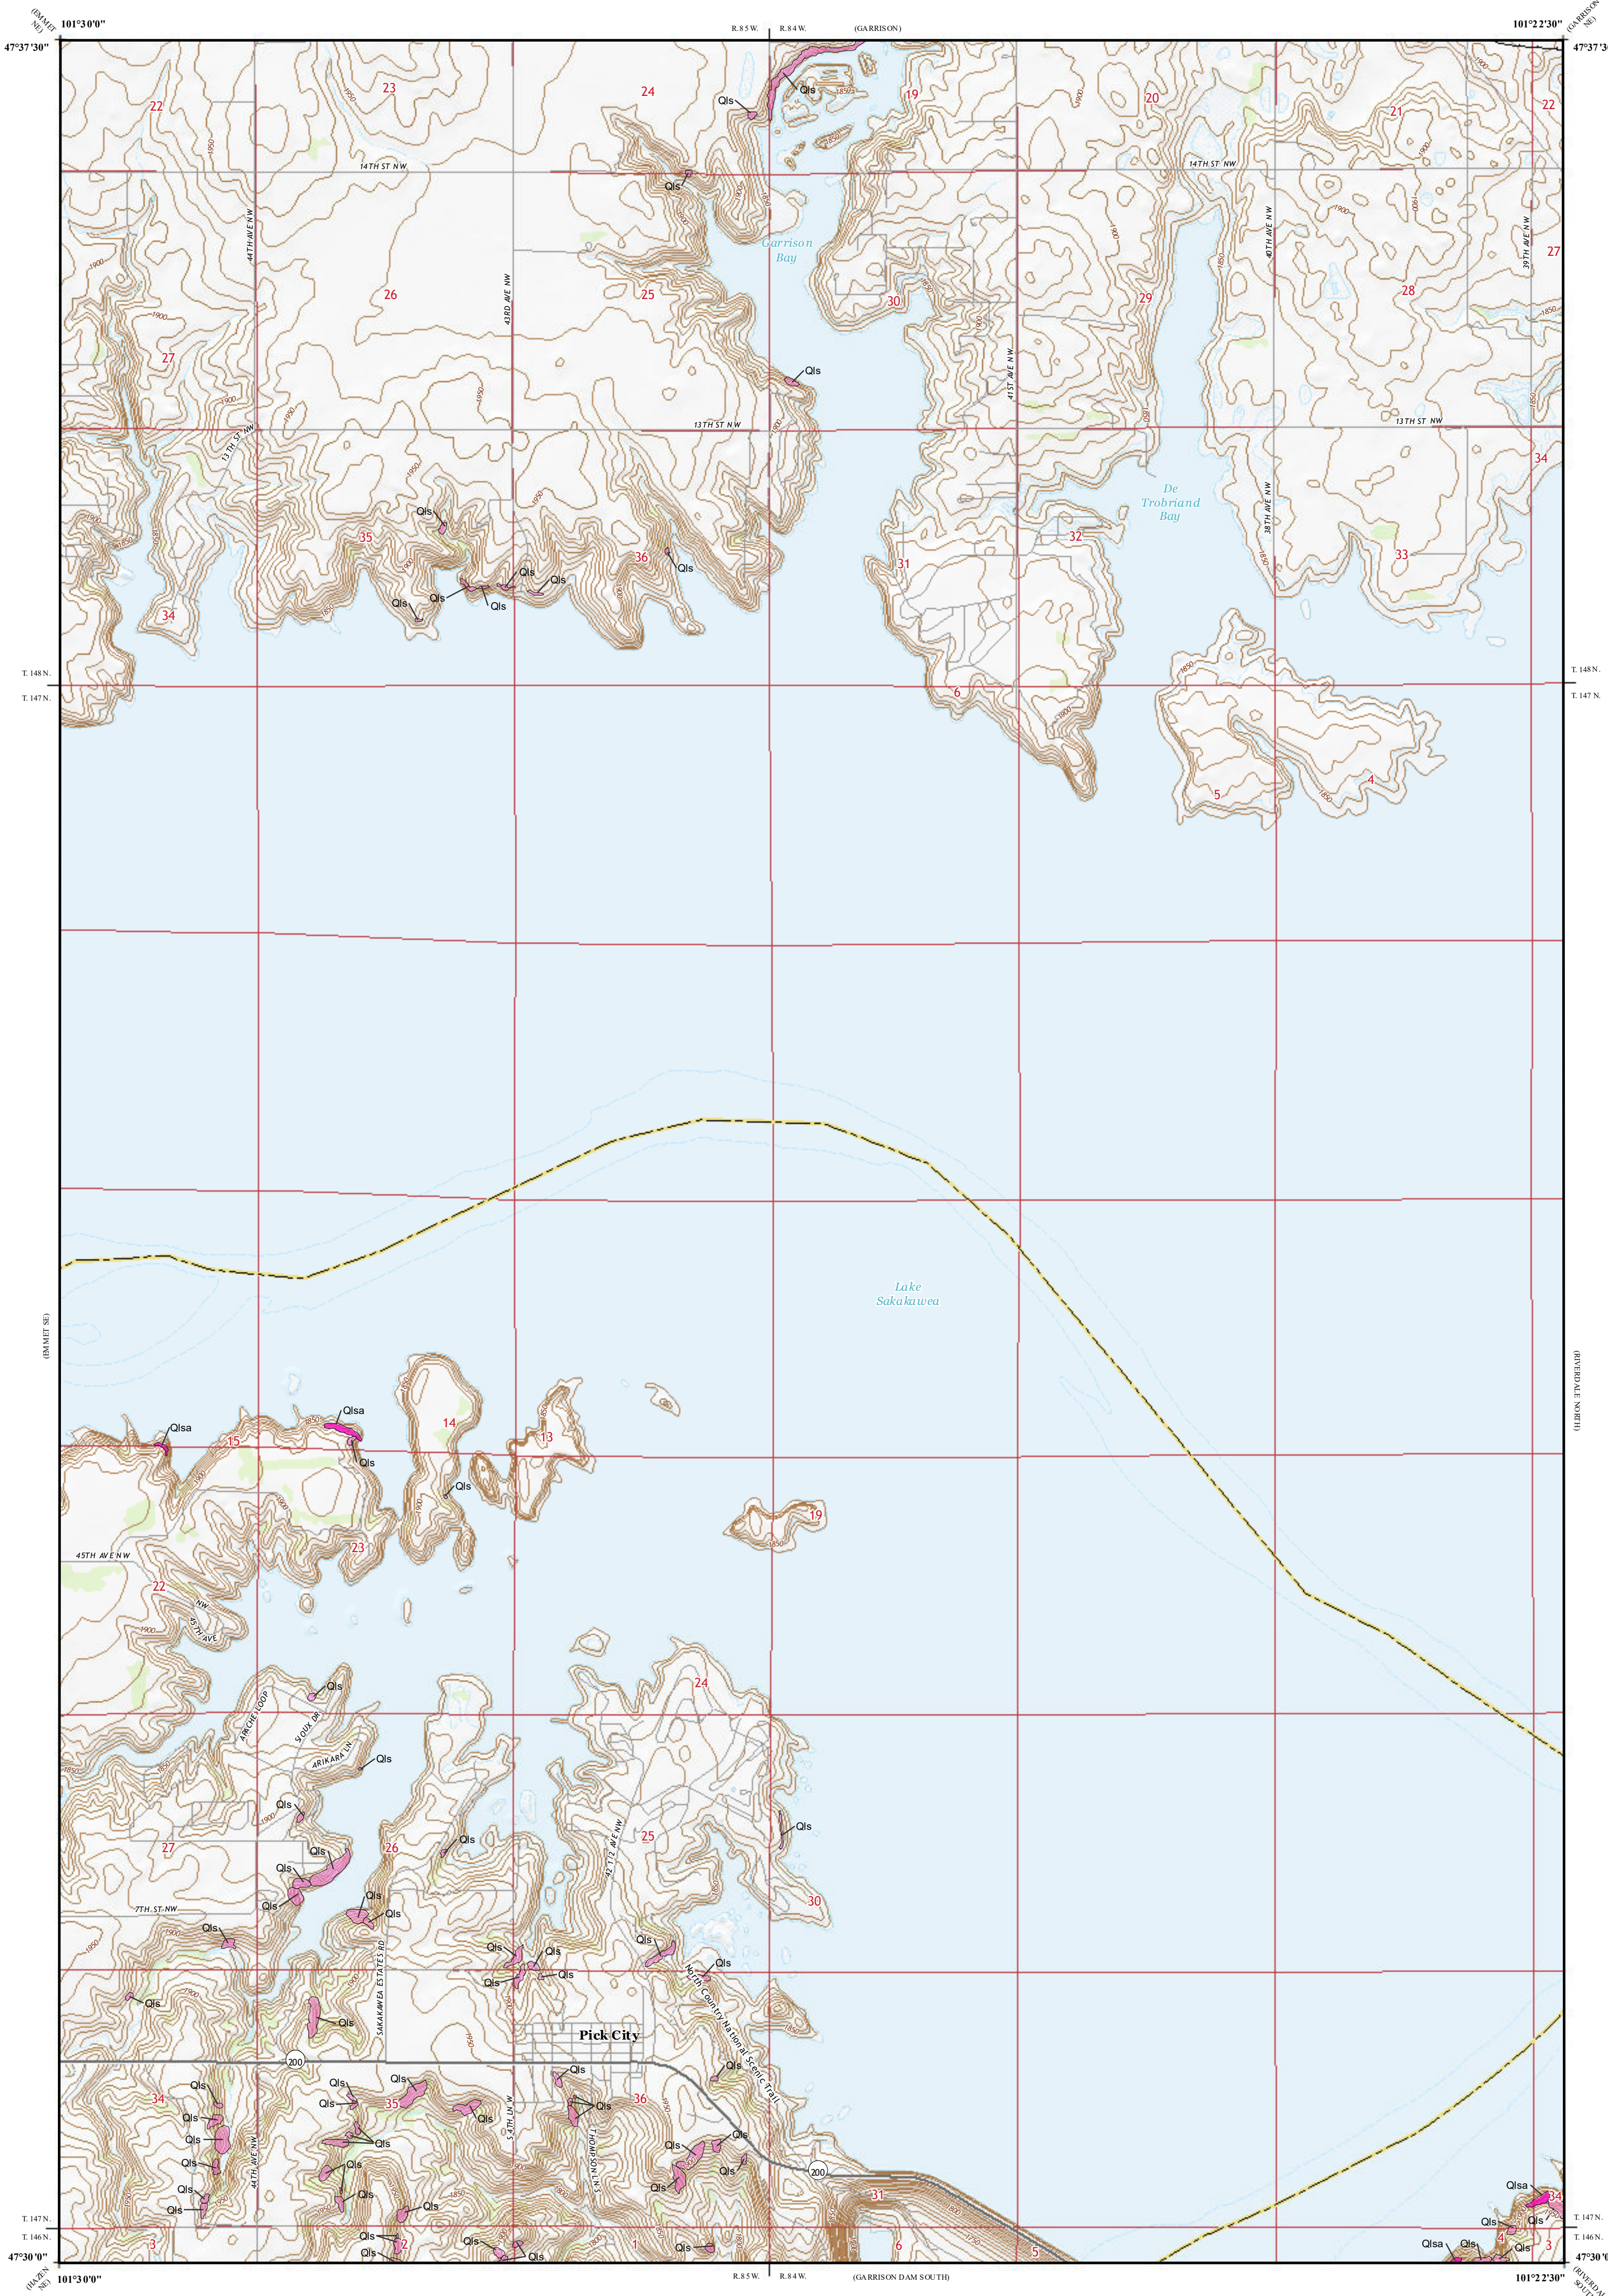
Garrison Dam North Quadrangle, North Dakota

Landslide areas showing movement between 2008 and 2021.

A mass of material that has moved downslope. Includes earth flows, slumps, and areas of soil creep.

Landslides identified on this quadrangle were mapped from stereo pairs, black and white 1:20,000 scale aerial photographs flown in 1958 by the United States Department of Agriculture (USDA). Additional data sources include digital orthophotography from the USDA National Agriculture Imagery Program (NAIP) flown in October 2021 and the North Dakota Geological Survey LiDAR Map Series, which compiles raw data flown in October 2021 from the North Dakota State Water Commission.

Areas of recently active landslides (Qlsa) mapped on this quadrangle were identified from changes between the 2008 and 2021 LiDAR elevation datasets observed on an elevation subtraction raster. Noise introduced from data precision (typically within a foot between the LiDAR datasets) is removed on this raster by excluding the signal from elevation change in the +/- 1 foot interval. Geologists interpret areas of landslide movement in geomorphic context (typically a decrease in elevation near a landslide headscarp paired with an increase in elevation downslope near the toe) and delineate those areas within the larger landslide dataset. Landslides not identified as recently active may have also experienced movement relatively recently, but did not show discernible signs of movement during the 2008 to 2021 window between LiDAR collects.

Slope Failure Statistical Summary				
Map Unit	No. of Landslides	Mapped Landslide Area		Map Area %
		acres	m <sup>2</sup>	
Total Landslides (Qls & Qlsa)	73	87	352,659	0.3
Recently Active Landslides (Qlsa)	4	7	29,928	0.02
8.4% of the mapped landslide area was active between 2008 and 2021
