Areas of Landslides

Park River Quadrangle, North Dakota

**Benjamin C. York
&
Christopher A. Maike**

2023

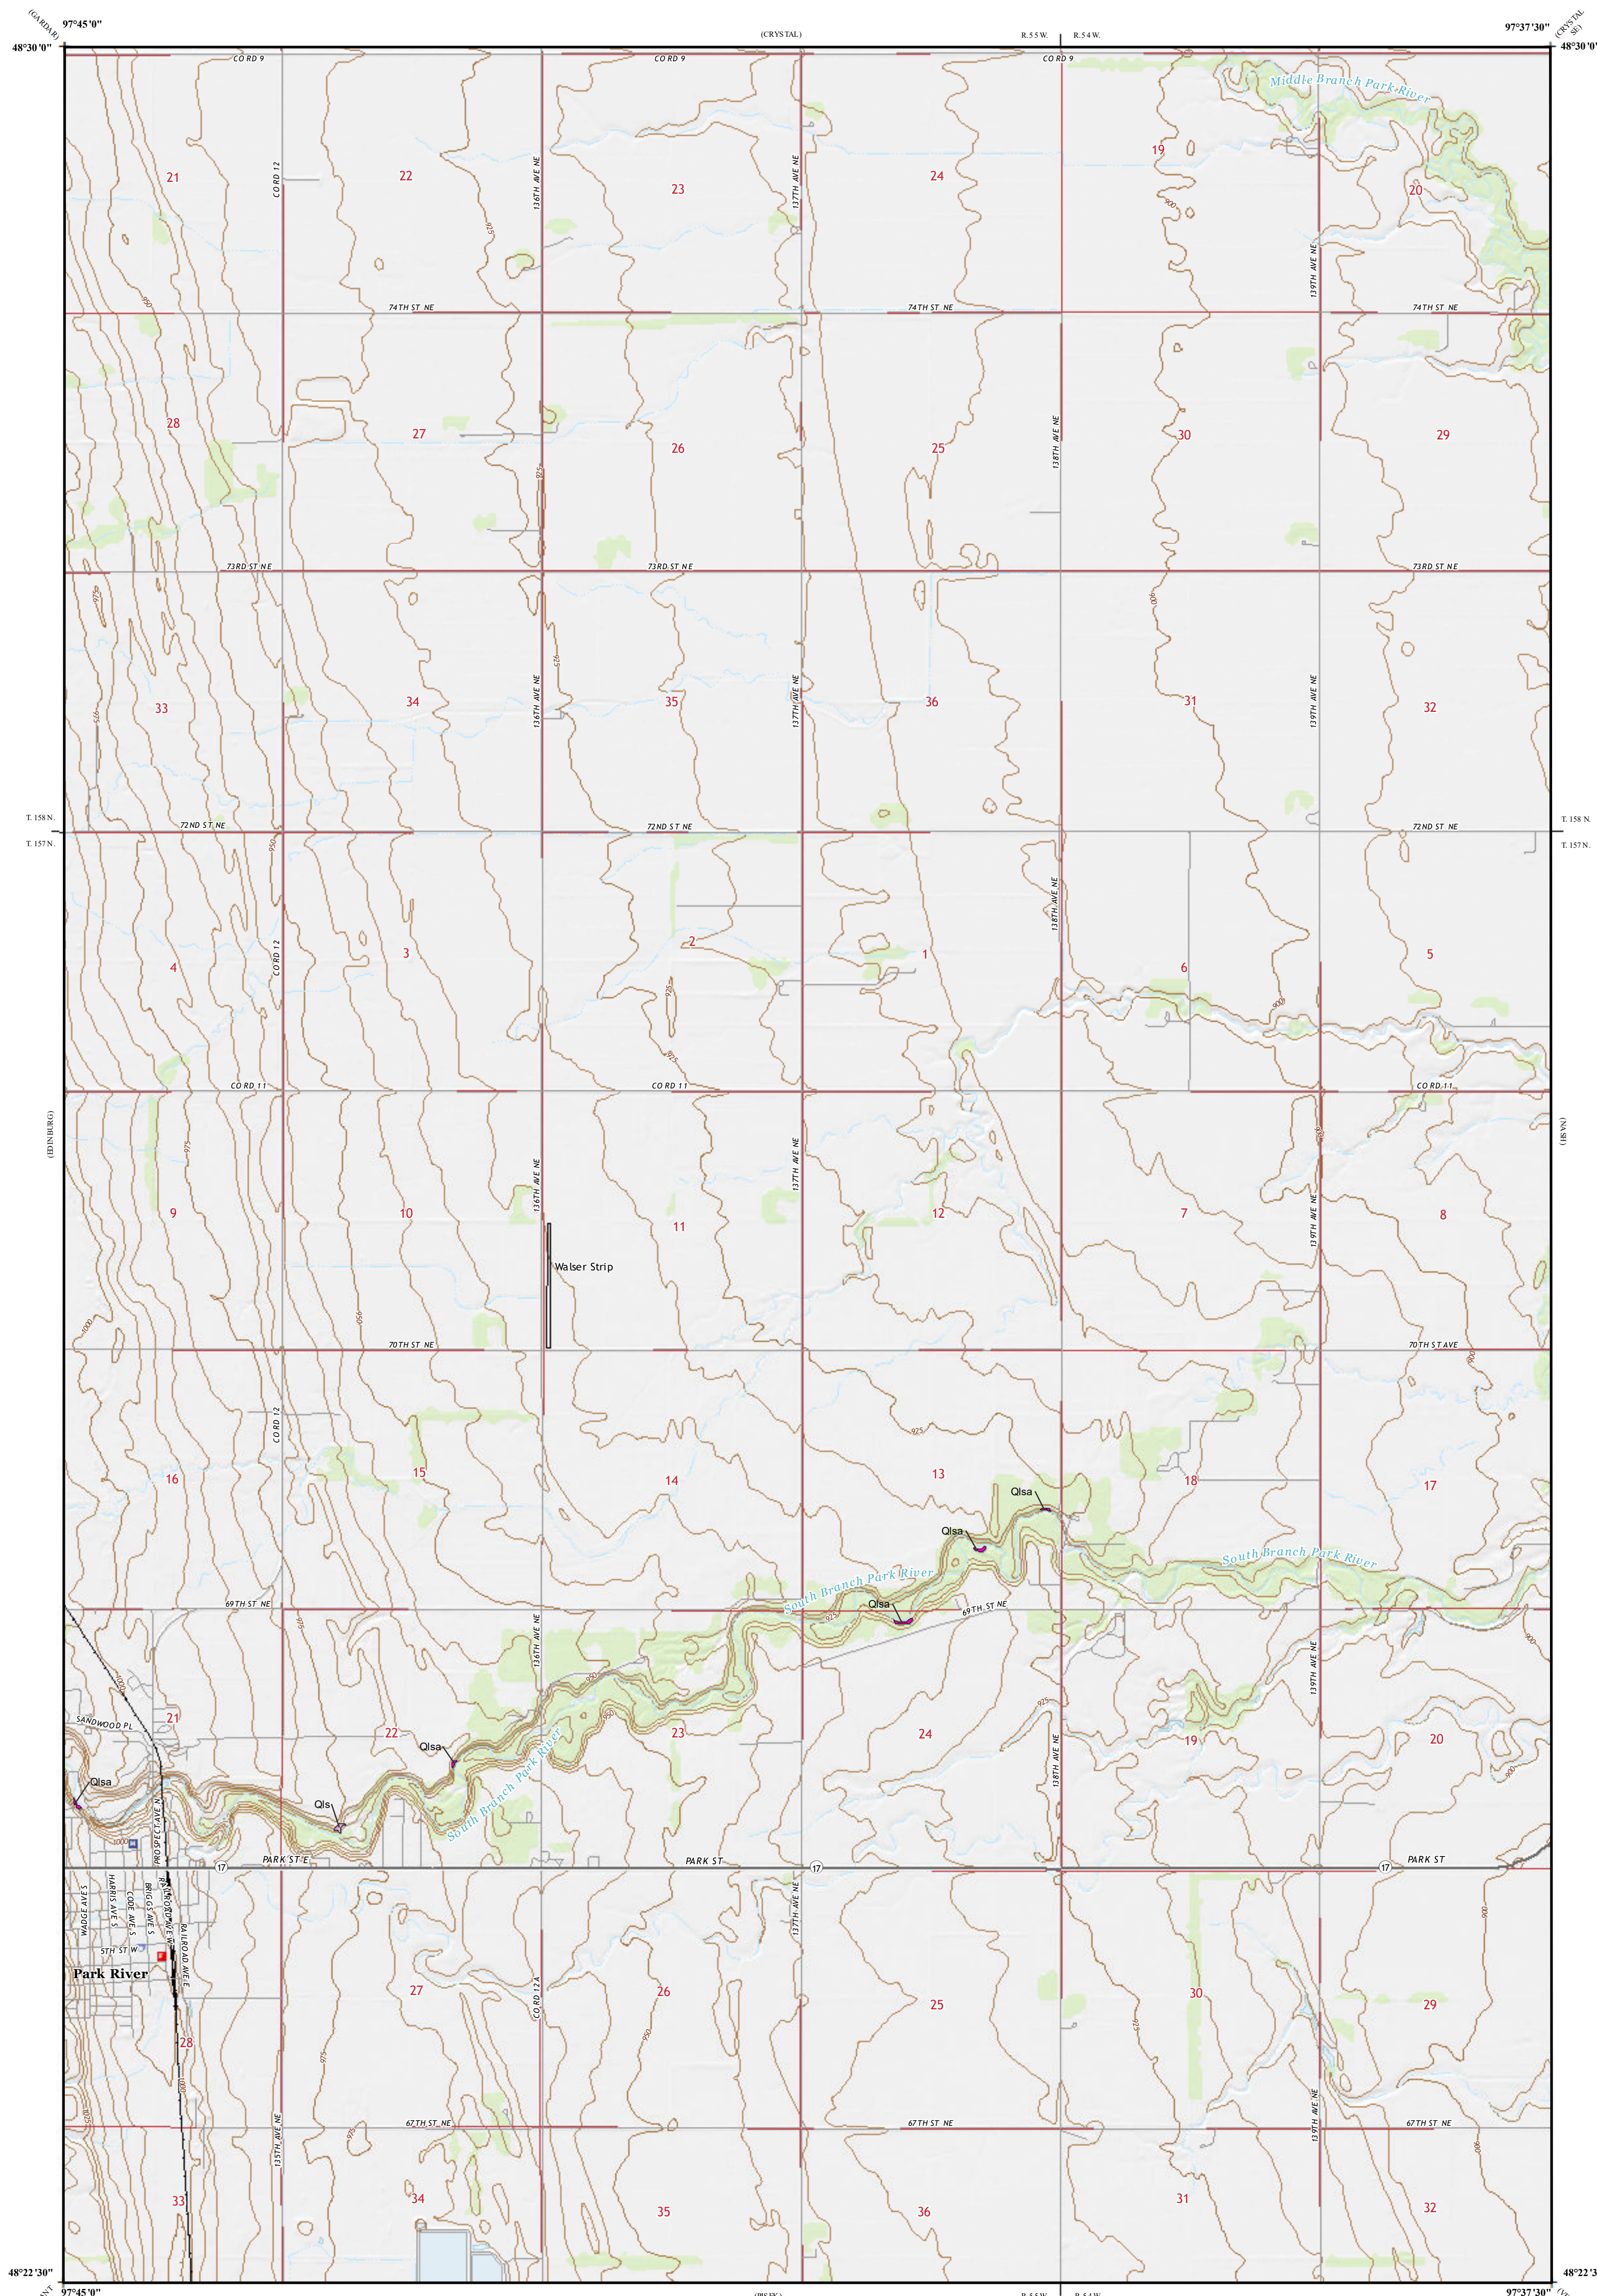
Qlsa Areas of Recently Active Landslides

Landslide areas showing movement between 2008 and 2020.

Qls Landslide Deposits

A mass of material that has moved downslope. Includes earth flows, slumps, and areas of soil creep.

Landslides identified on this quadrangle were mapped from stereo pairs, black and white 1:20,000 scale aerial photographs flown in 1962 by the United States Department of Agriculture (USDA). Additional data sources include digital orthophotography from the USDA National Agriculture Imagery Program (NAIP) flown in September 2021 and the North Dakota Geological Survey LiDAR Map Series, which compiles raw data flown in October to November 2020 from the North Dakota State Water Commission.

Areas of recently active landslides (Qlsa) mapped on this quadrangle were identified from changes between the 2008 and 2020 LiDAR elevation datasets observed on an elevation subtraction raster. Noise introduced from data precision (typically within a foot between the LiDAR datasets) is removed on this raster by excluding the signal from elevation change in the +/- 1 foot interval. Geologists interpret areas of landslide movement in geomorphic context (typically a decrease in elevation near a landslide headscarp paired with an increase in elevation downslope near the toe) and delineate those areas within the larger landslide dataset. Landslides not identified as recently active may have also experienced movement relatively recently, but did not show discernable signs of movement during the 2008 to 2020 window between LiDAR collects.

Slope Failure Statistical Summary

Map Unit	No. of Landslides	Mapped Landslide Area		Map Area %
		acres	m ²	
Total Landslides (Qls & Qlsa)	8	2	6,629	0.005
Recently Active Landslides (Qlsa)	7	1	4,752	0.003

71.68% of the mapped landslide area was active between 2008 and 2020
