Areas of Landslides

Lidgerwood Quadrangle, North Dakota

Levi D. Moxness

2023

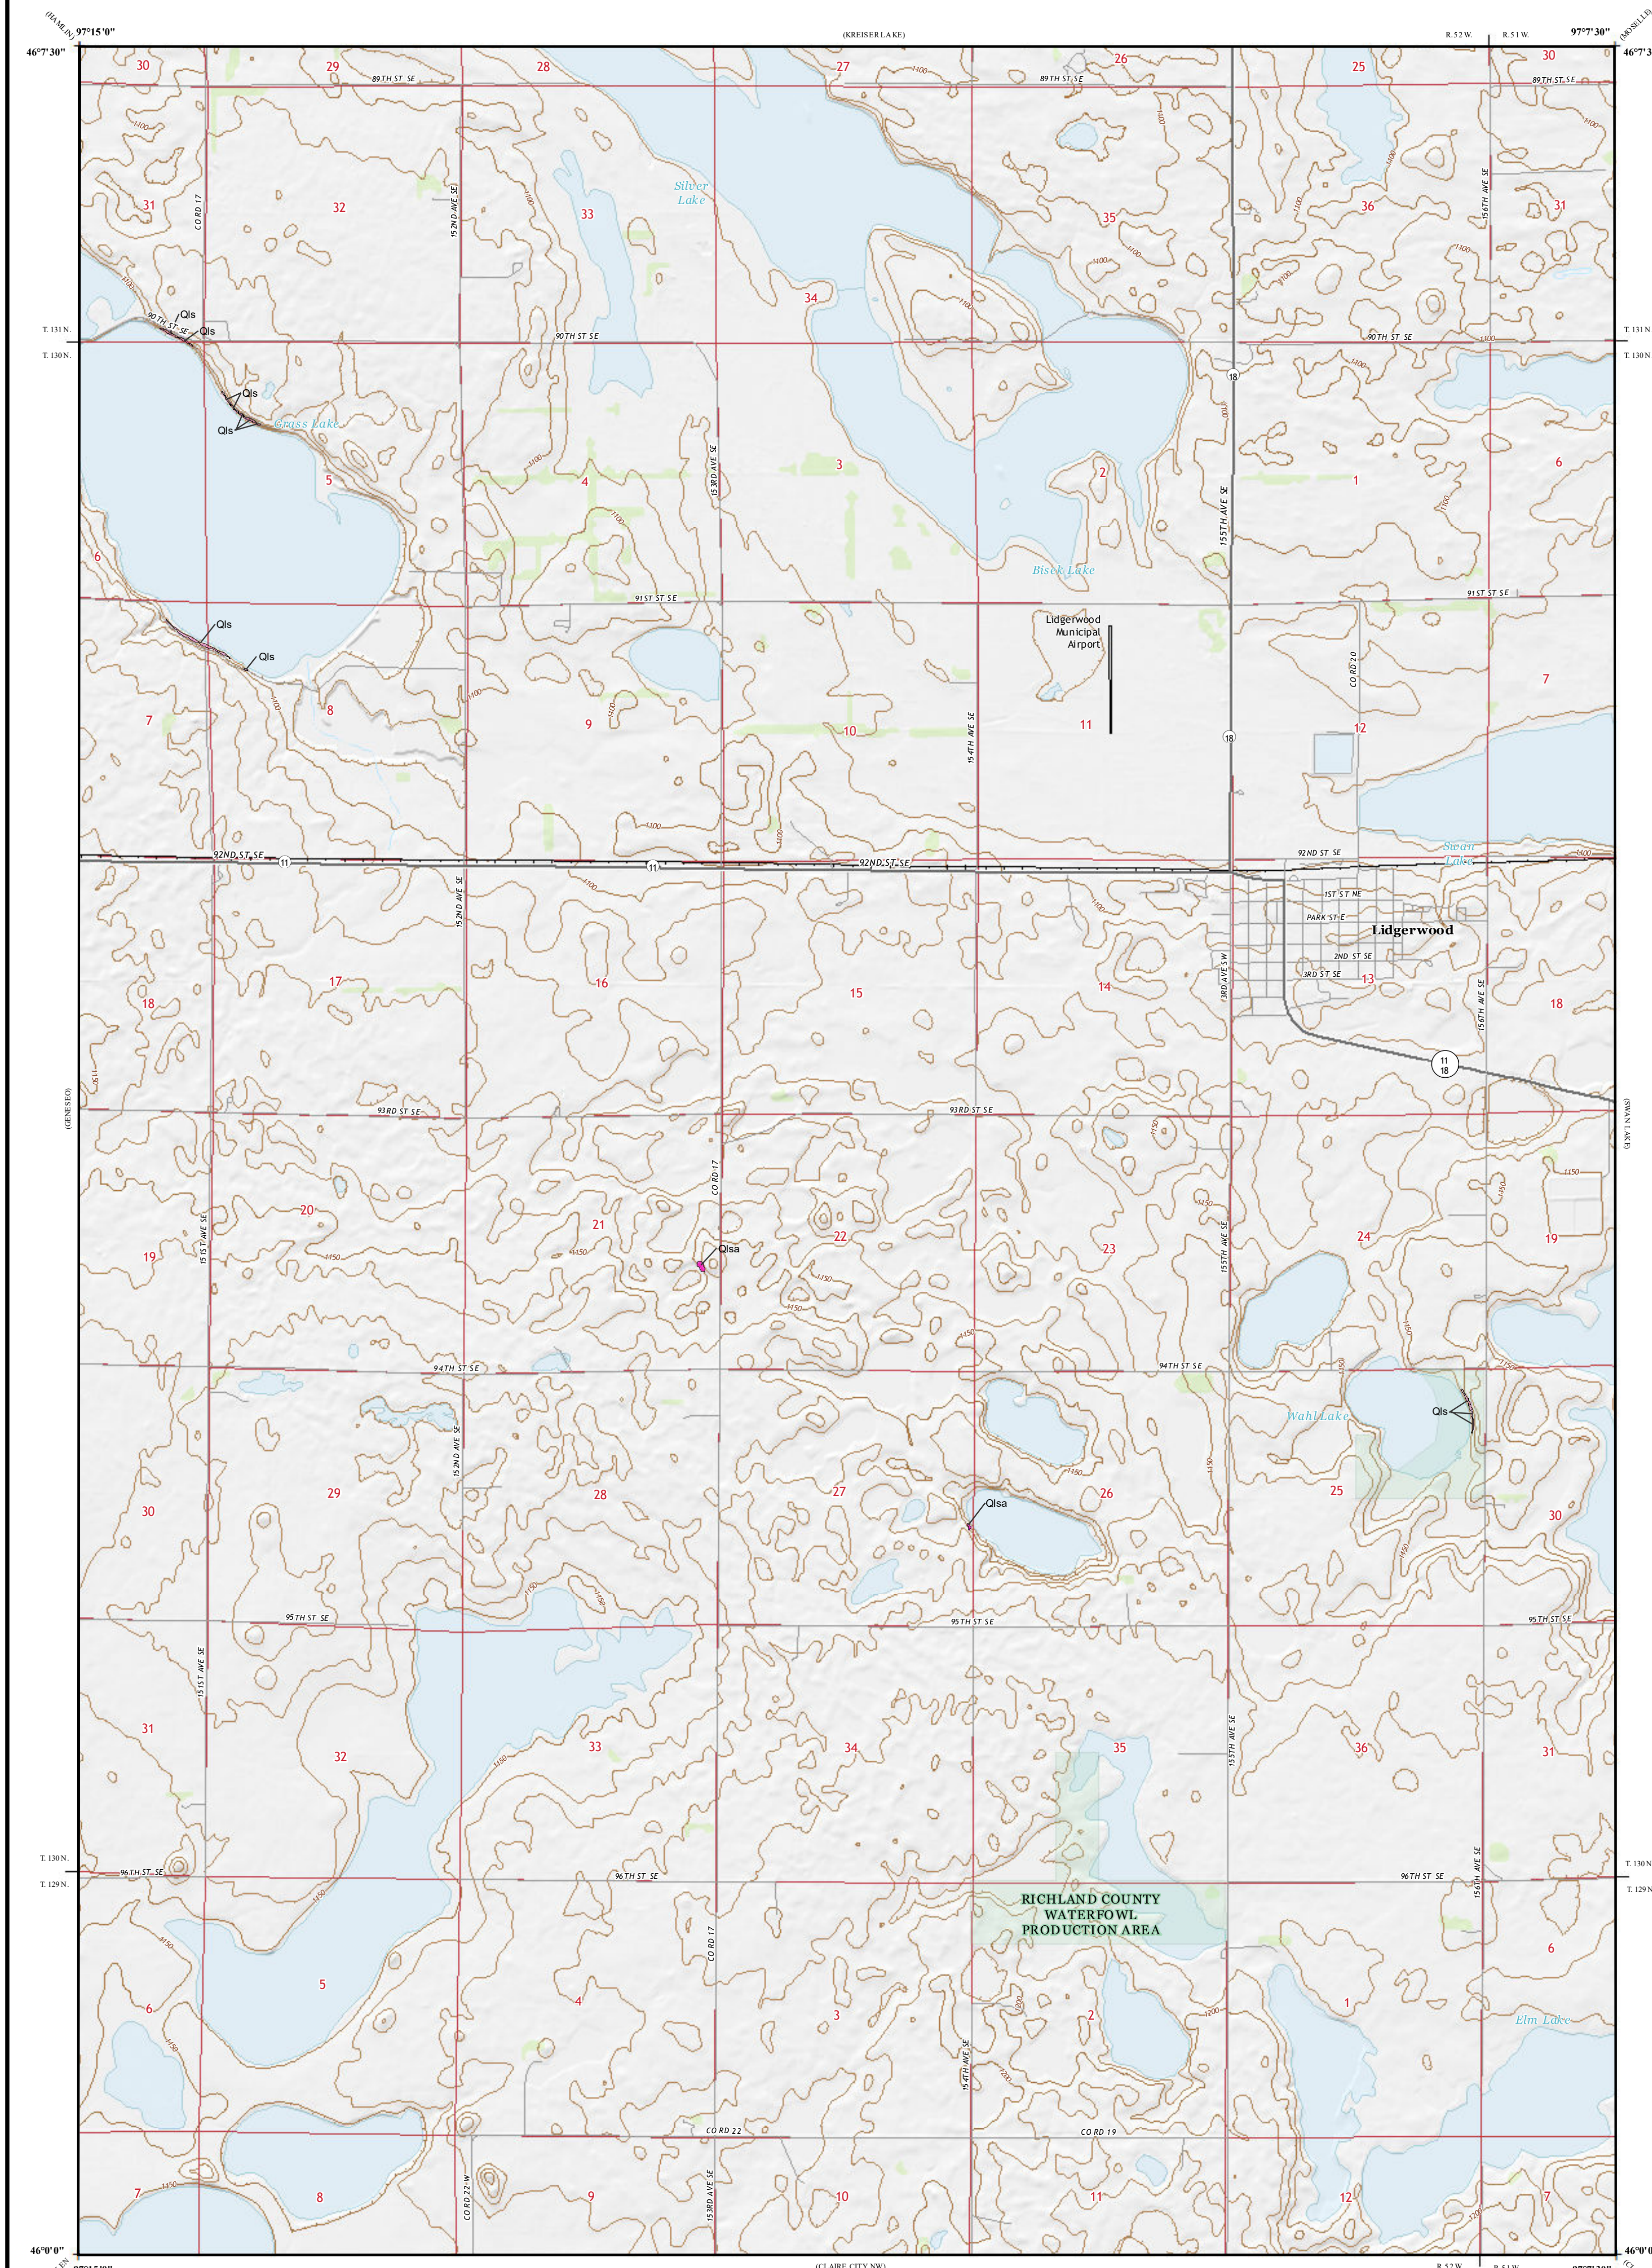
Qlsa Areas of Recently Active Landslides

Landslide areas showing movement between 2008 and 2019.

Qls Landslide Deposits

A mass of material that has moved downslope. Includes earth flows, slumps, and areas of soil creep.

Landslides identified on this quadrangle were mapped from stereo pairs, black and white 1:20,000 scale aerial photographs flown in August 1952 by the United States Department of Agriculture (USDA). Additional data sources include digital orthophotography from the USDA National Agriculture Imagery Program (NAIP) flown in September 2021 and the North Dakota Geological Survey LiDAR Map Series, which compiles raw data flown in June 2019 from the North Dakota State Water Commission.

Areas of recently active landslides (Qlsa) mapped on this quadrangle were identified from changes between the 2008 and 2019 LiDAR elevation datasets observed on an elevation subtraction raster. Noise introduced from data precision (typically within a foot between the LiDAR datasets) is removed on this raster by excluding the signal from elevation change in the +/- 1 foot interval. Geologists interpret areas of landslide movement in geomorphic context (typically a decrease in elevation near a landslide headscarp paired with an increase in elevation downslope near the toe) and delineate those areas within the larger landslide dataset. Landslides not identified as recently active may have also experienced movement relatively recently, but did not show discernable signs of movement during the 2008 to 2019 window between LiDAR collects.

Slope Failure Statistical Summary				
Map Unit	No. of Landslides	Mapped Landslide Area		Map Area %
		acres	m ²	
Total Landslides (Qls & Qlsa)	14	4	15,326	0.01
Recently Active Landslides (Qlsa)	2	1	2,676	0.002

17.45% of the mapped landslide area was active between 2008 and 2019
