Areas of Landslides

Fairmount NW Quadrangle, North Dakota

**Benjamin C. York
&
Levi D. Moxness**

2023

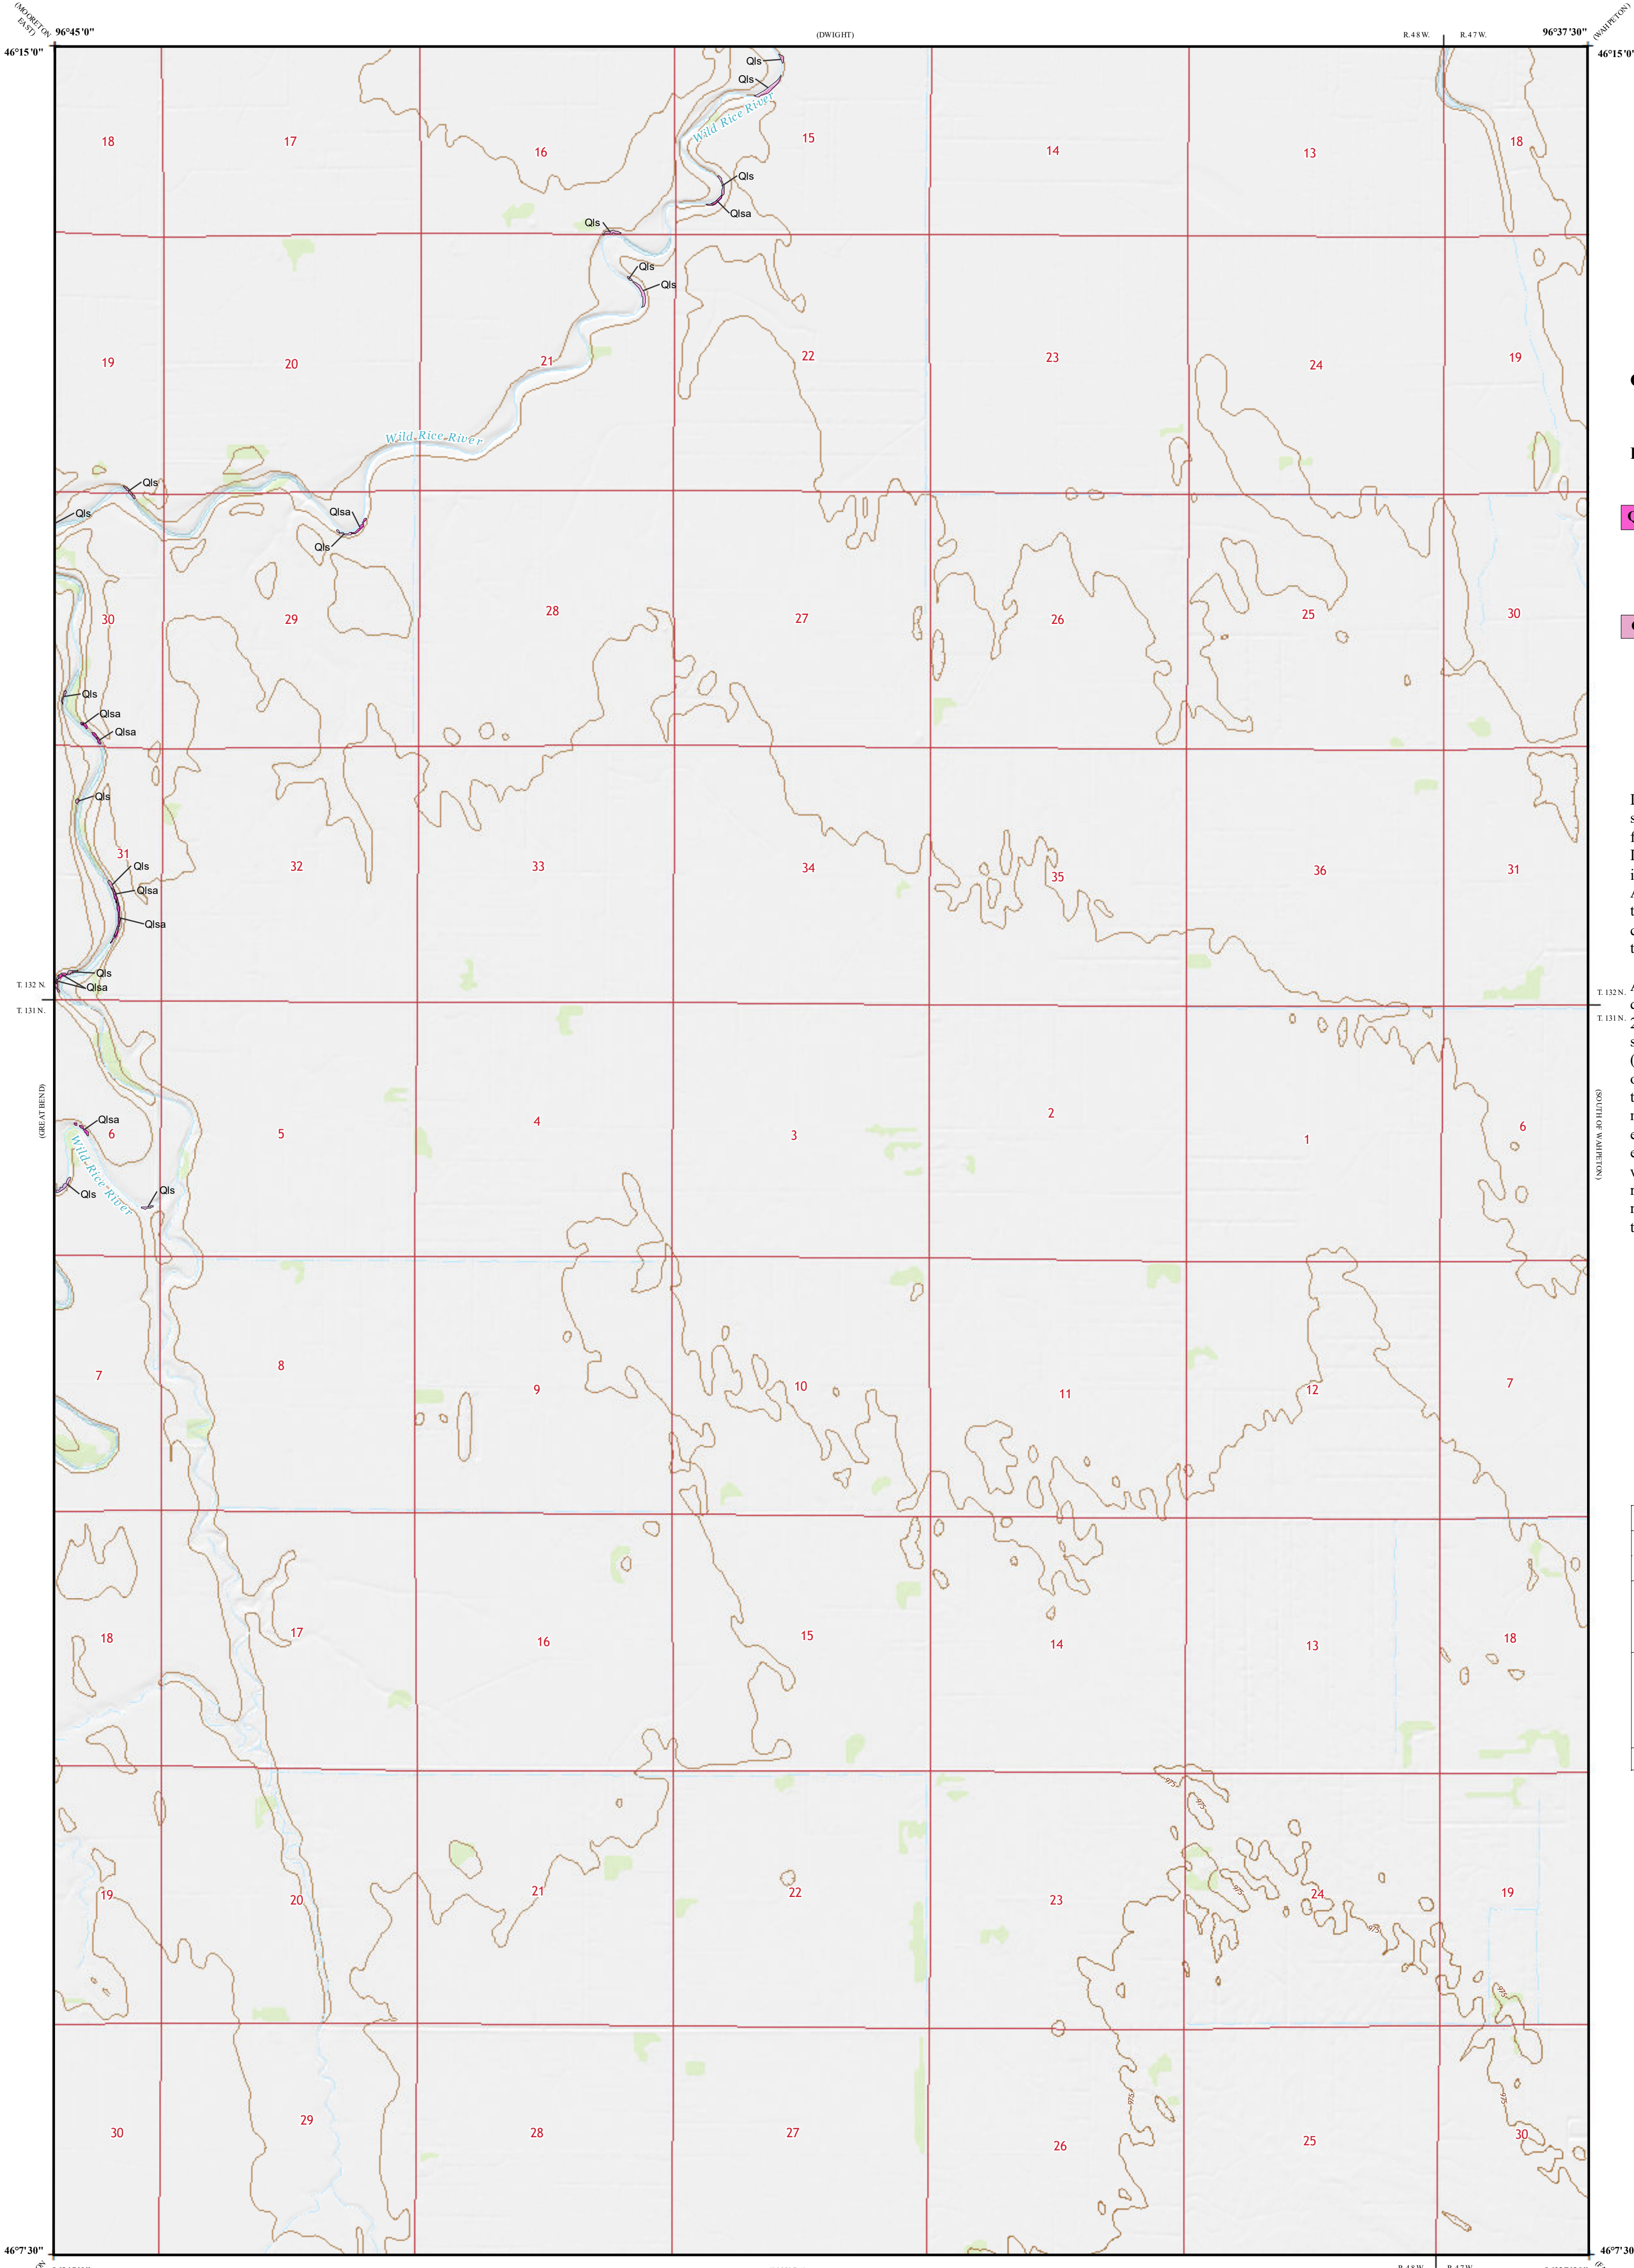
Qlsa Areas of Recently Active Landslides

Landslide areas showing movement between 2008 and 2020.

Qls Landslide Deposits

A mass of material that has moved downslope. Includes earth flows, slumps, and areas of soil creep.

Landslides identified on this quadrangle were mapped from stereo pairs, black and white 1:20,000 scale aerial photographs flown in August to September 1952 by the United States Department of Agriculture (USDA). Additional data sources include digital orthophotography from the USDA National Agriculture Imagery Program (NAIP) flown in August 2021 and the North Dakota Geological Survey LiDAR Map Series, which compiles raw data flown in November 2020 to April 2021 from the North Dakota State Water Commission.

Areas of recently active landslides (Qlsa) mapped on this quadrangle were identified from changes between the 2008 and 2021 LiDAR elevation datasets observed on an elevation subtraction raster. Noise introduced from data precision (typically within a foot between the LiDAR datasets) is removed on this raster by excluding the signal from elevation change in the +/- 1 foot interval. Geologists interpret areas of landslide movement in geomorphic context (typically a decrease in elevation near a landslide headscarp paired with an increase in elevation downslope near the toe) and delineate those areas within the larger landslide dataset. Landslides not identified as recently active may have also experienced movement relatively recently, but did not show discernable signs of movement during the 2008 to 2021 window between LiDAR collects.

Slope Failure Statistical Summary				
Map Unit	No. of Landslides	Mapped Landslide Area		Map Area %
		acres	m ²	
Total Landslides (Qls & Qlsa)	30	9	36,558	0.02
Recently Active Landslides (Qlsa)	12	3	10,426	0.01
28.5% of the mapped landslide area was active between 2008 and 2021
