# Areas of Landslides

## Mantador Quadrangle, North Dakota

**Benjamin C. York  
&  
Levi D. Moxness**

**2023**

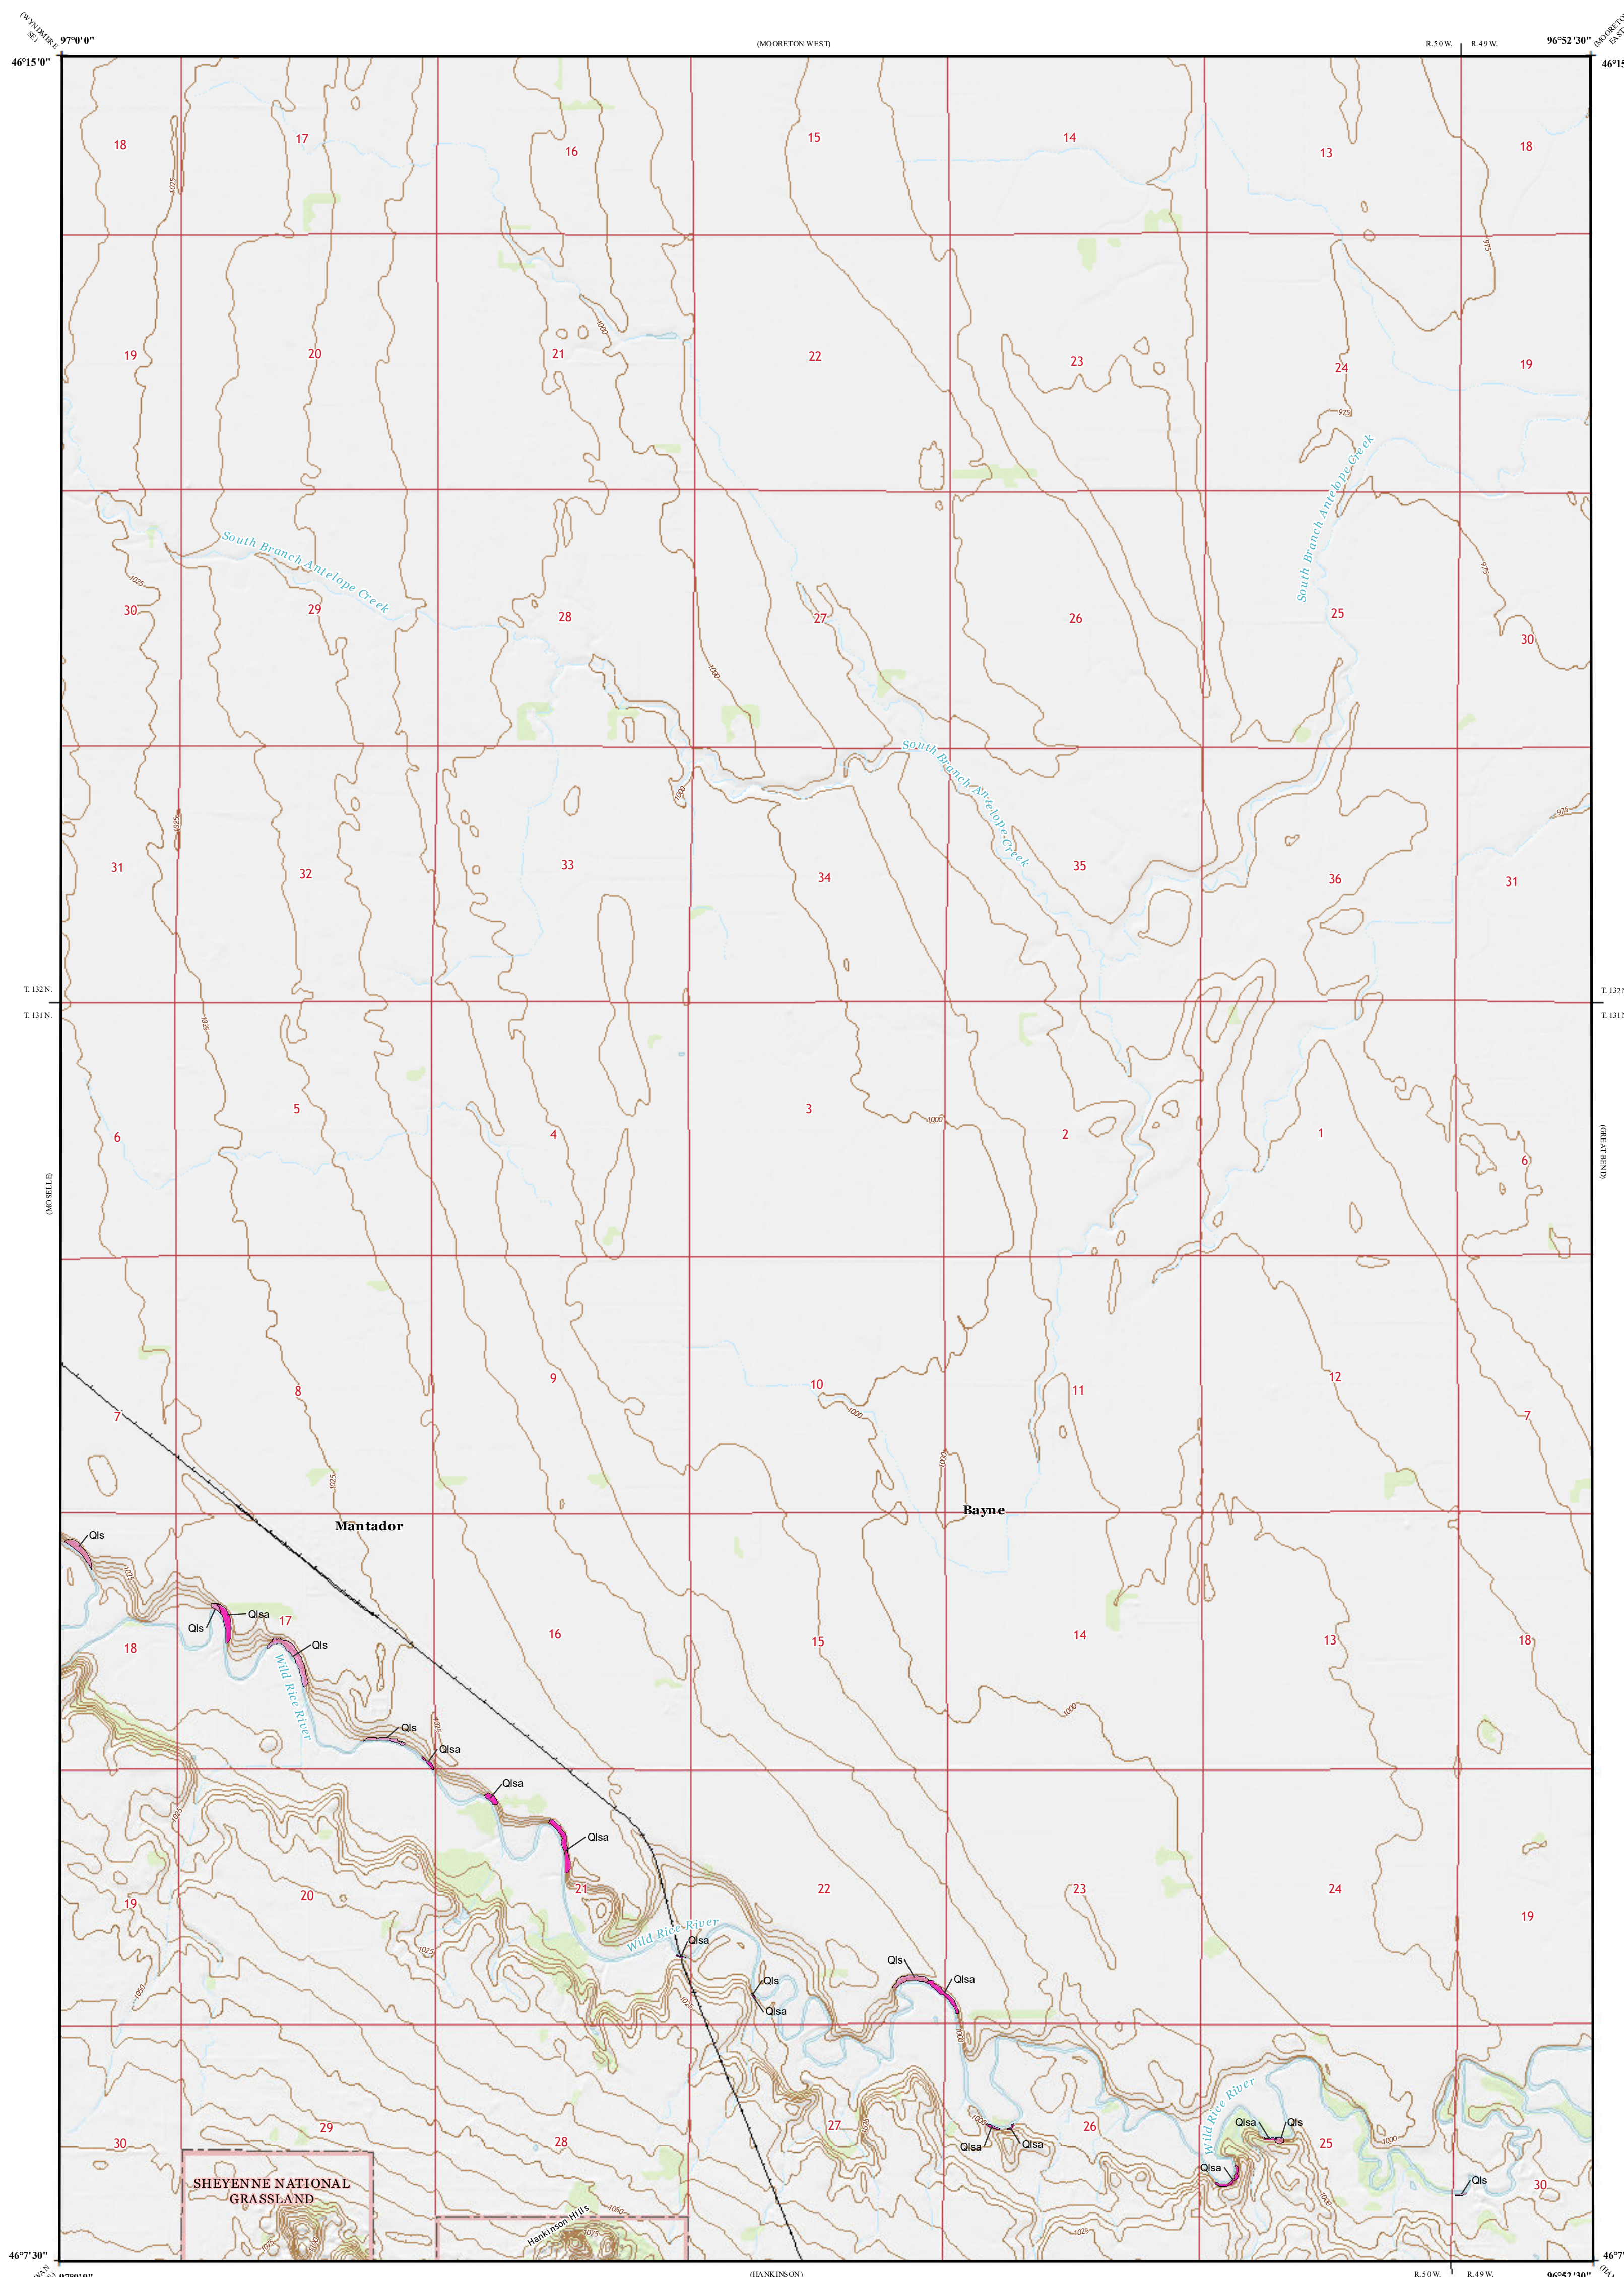
Mantador Quadrangle, North Dakota

#### Qlsa Areas of Recently Active Landslides

Landslide areas showing movement between 2008 and 2020.

#### Qls Landslide Deposits

A mass of material that has moved downslope. Includes earth flows, slumps, and areas of soil creep.

Landslides identified on this quadrangle were mapped from stereo pairs, black and white 1:20,000 scale aerial photographs flown in August to September 1952 by the United States Department of Agriculture (USDA). Additional data sources include digital orthophotography from the USDA National Agriculture Imagery Program (NAIP) flown in August 2021 and the North Dakota Geological Survey LiDAR Map Series, which compiles raw data flown in May 2019 from the North Dakota State Water Commission.

Areas of recently active landslides (Qlsa) mapped on this quadrangle were identified from changes between the 2008 and 2019 LiDAR elevation datasets observed on an elevation subtraction raster. Noise introduced from data precision (typically within a foot between the LiDAR datasets) is removed on this raster by excluding the signal from elevation change in the +/- 1 foot interval. Geologists interpret areas of landslide movement in geomorphic context (typically a decrease in elevation near a landslide headscarp paired with an increase in elevation downslope near the toe) and delineate those areas within the larger landslide dataset. Landslides not identified as recently active may have also experienced movement relatively recently, but did not show discernable signs of movement during the 2008 to 2019 window between LiDAR collects.

Slope Failure Statistical Summary				
Map Unit	No. of Landslides	Mapped Landslide Area		Map Area %
		acres	m <sup>2</sup>	
Total Landslides (Qls & Qlsa)	19	18	73,829	0.05
Recently Active Landslides (Qlsa)	11	8	34,225	0.02

46.35% of the mapped landslide area was active between 2008 and 2019
