Areas of Landslides

Mooreton East Quadrangle, North Dakota

2023

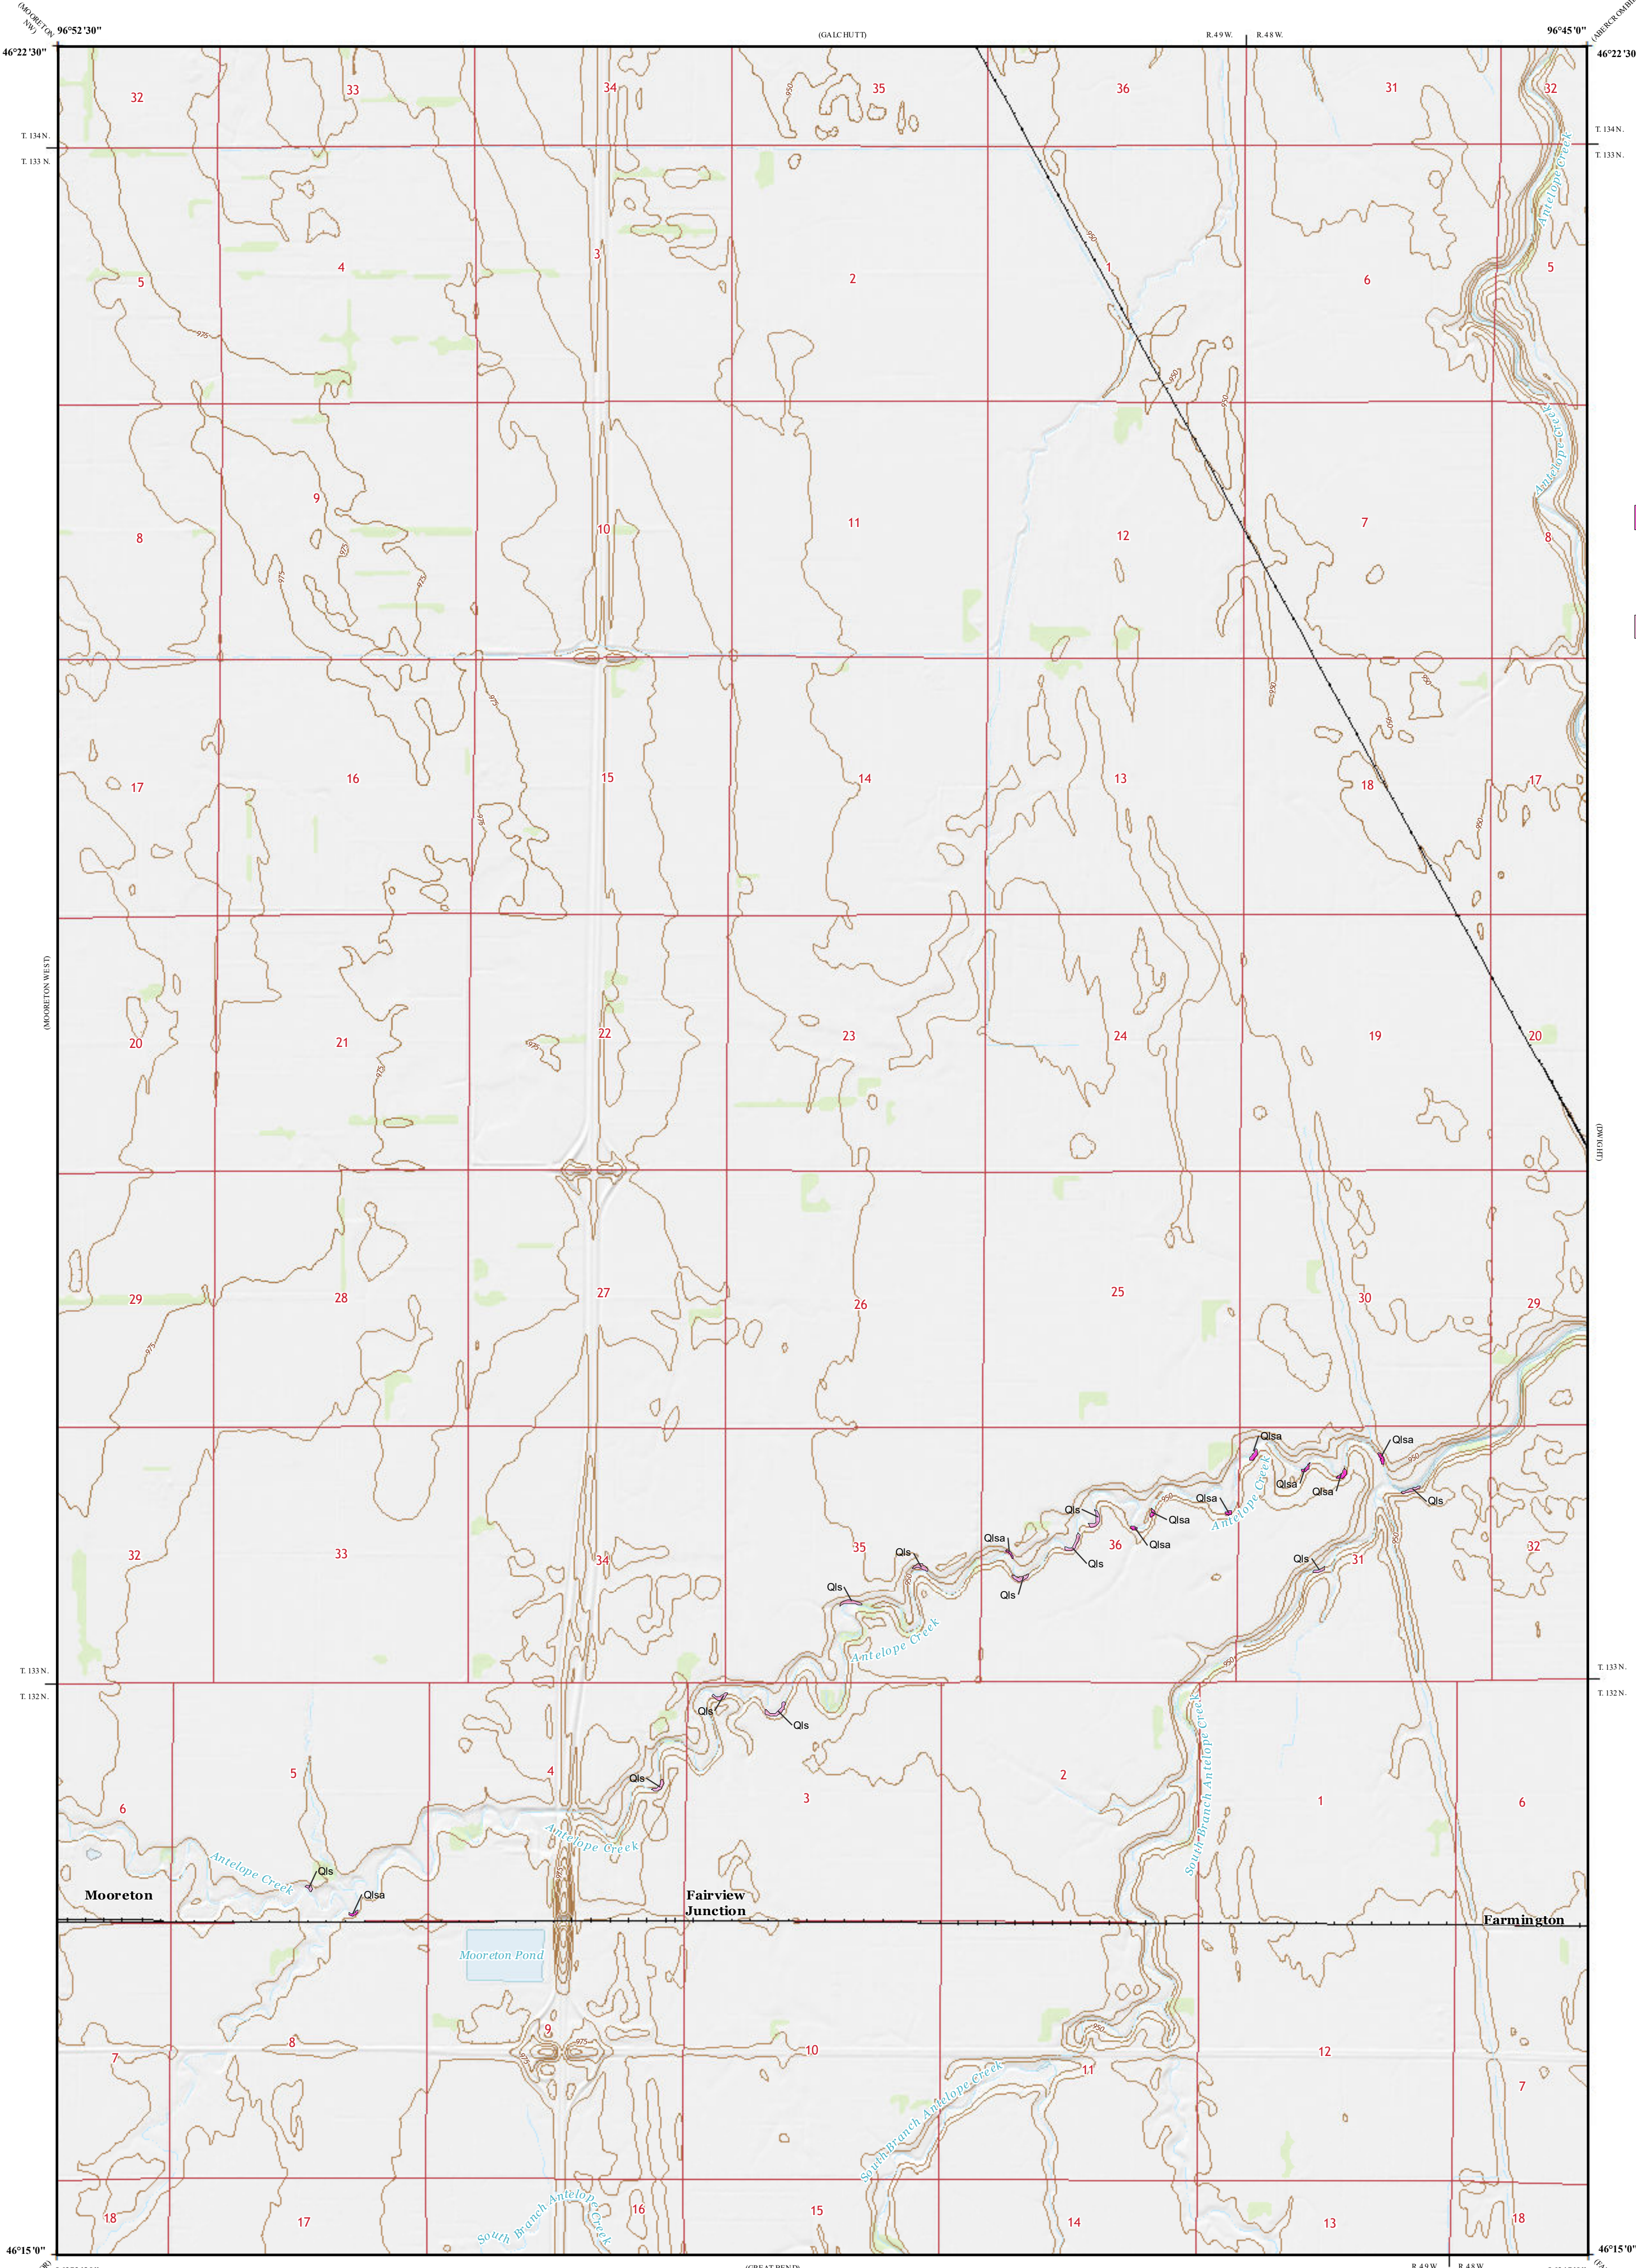
Mooreton East Quadrangle, North Dakota

Q_{sa} Areas of Recently Active Landslides

Landslide areas showing movement between 2008 and 2020.

Q_s Landslide Deposits

A mass of material that has moved downslope. Includes earth flows, slumps, and areas of soil creep.

Landslides identified on this quadrangle were mapped from stereo pairs, black and white 1:20,000 scale aerial photographs flown in August to September 1952 by the United States Department of Agriculture (USDA). Additional data sources include digital orthophotography from the USDA National Agriculture Imagery Program (NAIP) flown in August 2021 and the North Dakota Geological Survey LiDAR Map Series, which compiles raw data flown in May 2019 to April 2021 from the North Dakota State Water Commission.

Areas of recently active landslides (Q_{sa}) mapped on this quadrangle were identified from changes between the 2008 and 2021 LiDAR elevation datasets observed on an elevation subtraction raster. Noise introduced from data precision (typically within a foot between the LiDAR datasets) is removed on this raster by excluding the signal from elevation change in the +/- 1 foot interval. Geologists interpret areas of landslide movement in geomorphic context (typically a decrease in elevation near a landslide headscarp paired with an increase in elevation downslope near the toe) and delineate those areas within the larger landslide dataset. Landslides not identified as recently active may have also experienced movement relatively recently, but did not show discernable signs of movement during the 2008 to 2021 window between LiDAR collects.

Slope Failure Statistical Summary				
Map Unit	No. of Landslides	Mapped Landslide Area		Map Area %
		acres	m ²	
Total Landslides (Q _s & Q _{sa})	20	9	35,532	0.02
Recently Active Landslides (Q _{sa})	9	0	1,891	0.001
5.32% of the mapped landslide area was active between 2008 and 2021
